CAPABILITIES OF PILE INTEGRITY TESTING

**PDA USERS DAY 1989
CLEVELAND, OHIO**

C. Michael Morgano

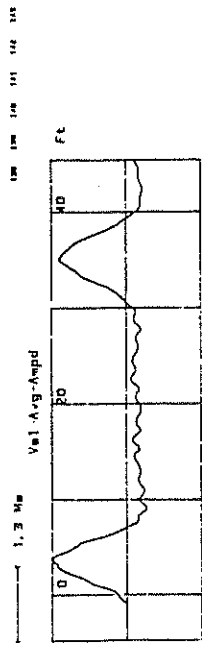
a)

| Figure | 1a: | Uniform pile |

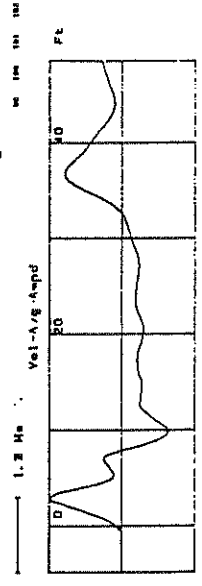
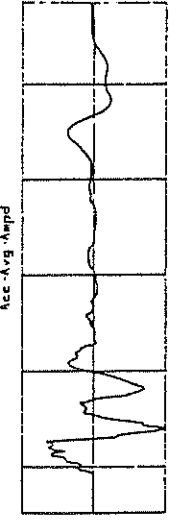
b)

| | 1b: | Slight necking and then crosssectional increase at 7 ft; larger cross section likely beginning at 10 ft. |

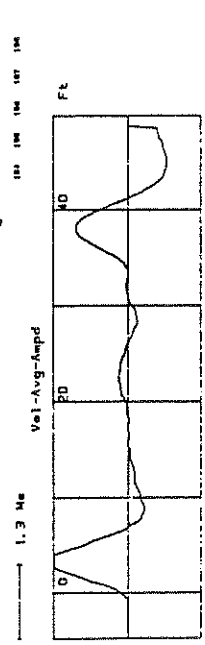
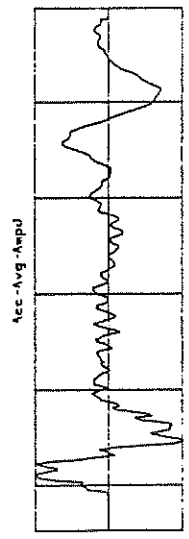
c)

- 1c: Soft soil at 10 ft or possibly a slight gradual decrease in impedance from 10 to 22 ft.
- 1d: Small outgrowth at 18 ft.

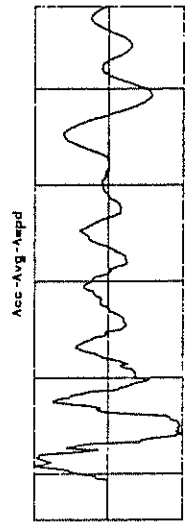
a)

- Figure
- 2a: Slight impedance decrease at 7 ft; however pile is continues.
 - 2b: A more significant impedance decrease is evident at 10 ft. Pile is also continues.
 - 2c: Slight impedance decrease at approximately 6 ft. This observation is made since a change of slope is indicated following the peak input. However, the pile is also continues since the toe reflection is present.
 - 2d: A large decrease in impedance at 4 ft. Pile is severely damaged and most likely broken since the toe reflection is not present.

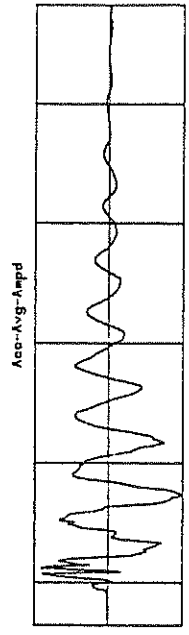
d)

All the records in Figure 2, except 2d, contain a reflection from the pile toe. Figure 2d does not contain a toe reflection. These four piles contain some degree of non uniformity in terms of an impedance decrease. Notes concerning the integrity of these piles are as follows:

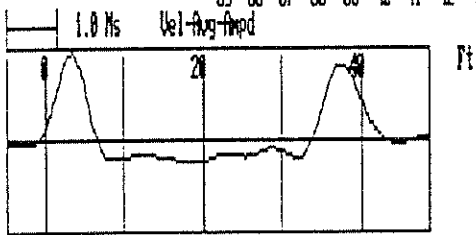
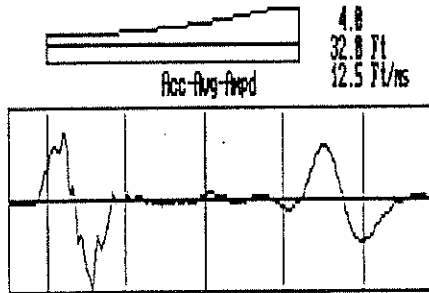
a)

The two records in Figure 3 show a pile with no major discontinuities (3a) and one pile broken at approximately 5 ft below the pile top (3b). Note once again the toe reflection is present for the sound pile and not for the broken pile. Also note that the output of these two records was from a graphics printer rather than a pen plotter.

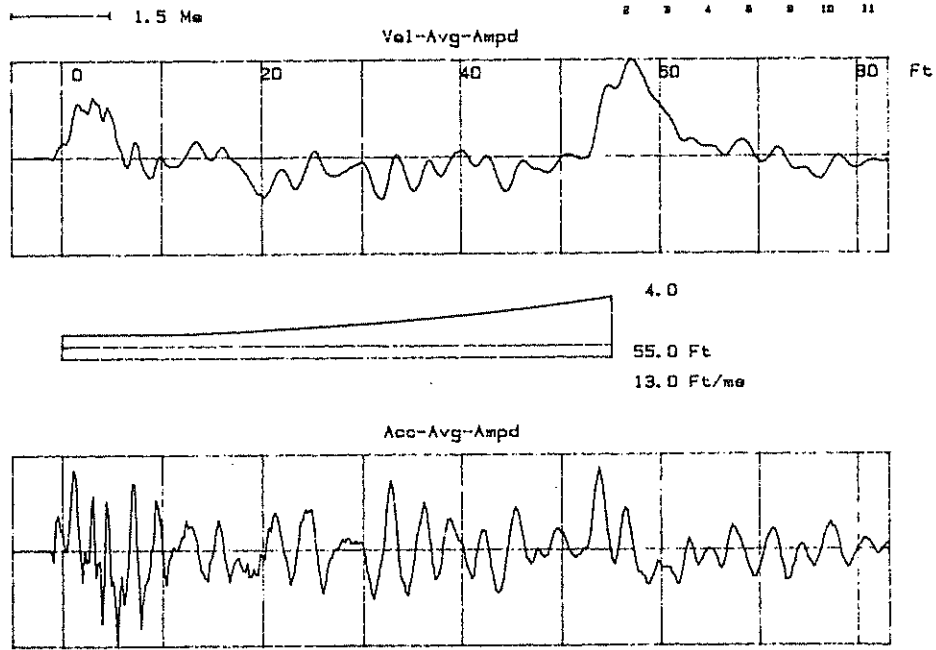
a)

- Figure 4a: This pile survived the high strain test with, at most, some slight cracking. A clear toe signal indicates that the pile is basically sound.
- 4b: This pile apparently has several cracks which did not allow the wave to penetrate to the pile toe. The pile top mortar also may have caused difficulties.
- Figure 5: This pile was of particular interest since during testing site personnel had given this pile a length of 55 ft. Based on the low strain records, the on-site diagnosis stated that a major crack was found at 42 ft. Later it was determined that the pile had been manufactured with a length of only 45 ft. Record inspection now showed that a decrease in impedance is likely at 42 ft with the toe producing a second strong velocity increase at 45 ft. The pile is practically sound since it did produce a toe signal.

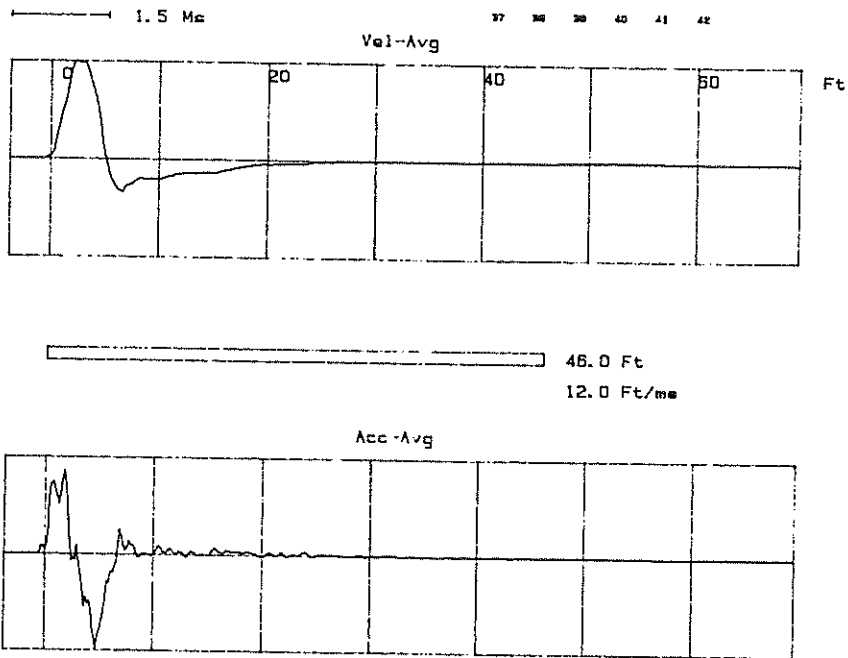
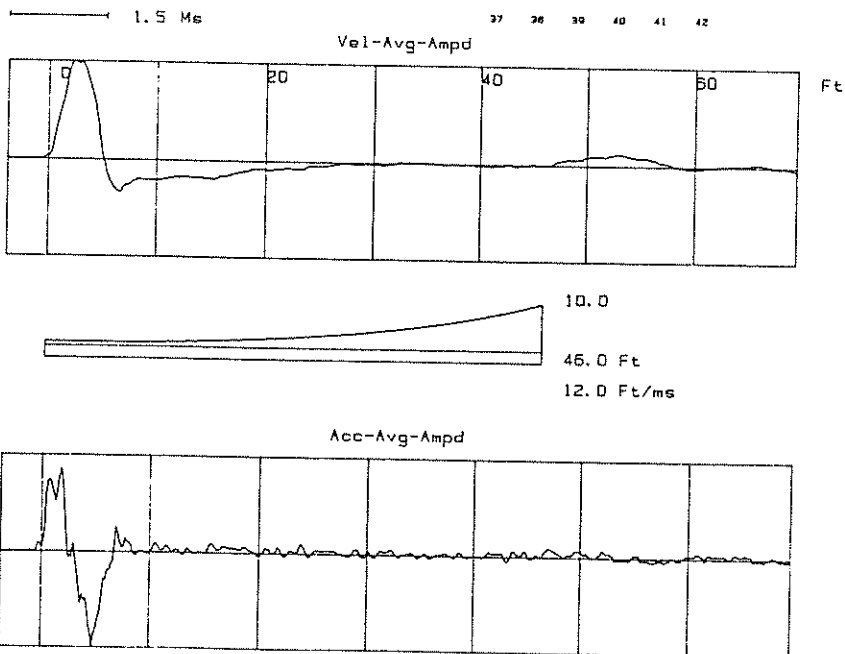
Figure 7

As a rule of thumb, a toe reflection is usually seen for piles with lengths up to 30 pile diameters. For a 16 inch pile, this length would correspond to 40 ft. Therefore, one would expect difficulties in obtaining a toe reflection of a 46 ft. pile. Indeed, as can be seen in Figure 7a, a toe reflection is not evident.

However, further inspection, while making use of the exponential magnification routine, revealed that a reflection from the pile toe is indeed present. Figures 7b, 8a and 8b show a series of the identical record as shown in Figure 7a, except with different magnifications.

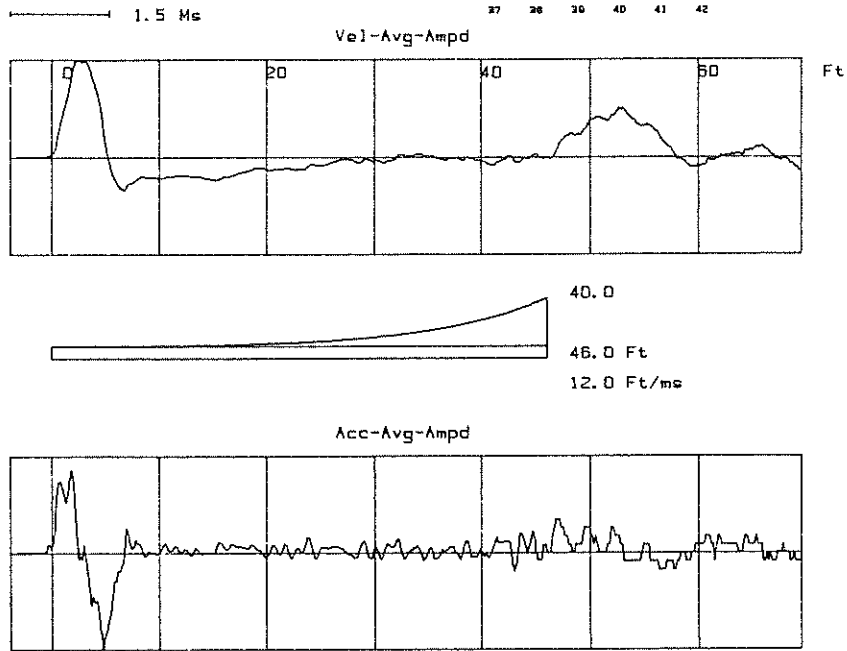
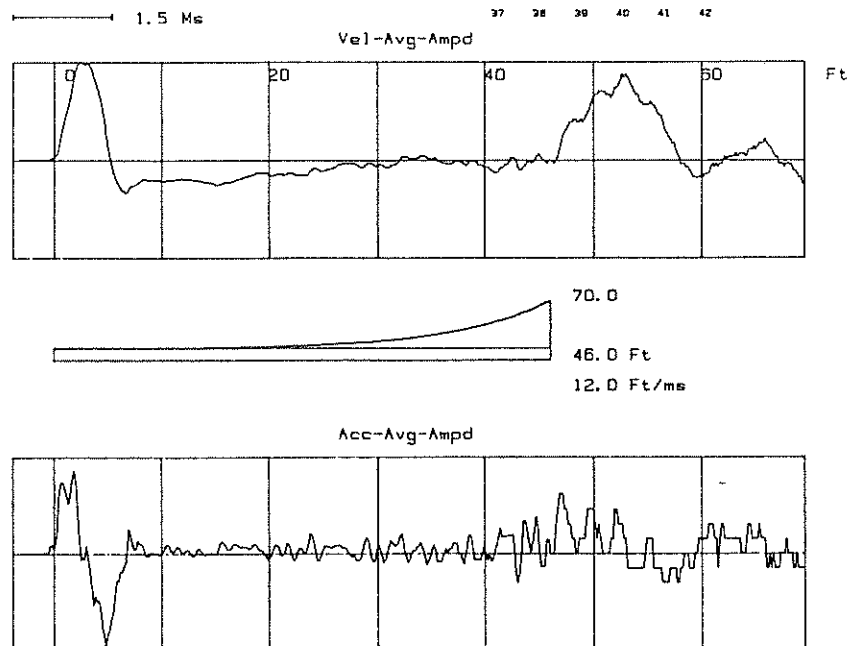
Figure 8

Note that magnifications values greater than 10 are necessary to see the toe reflection. At a magnification of 70, the reflection is very clear.

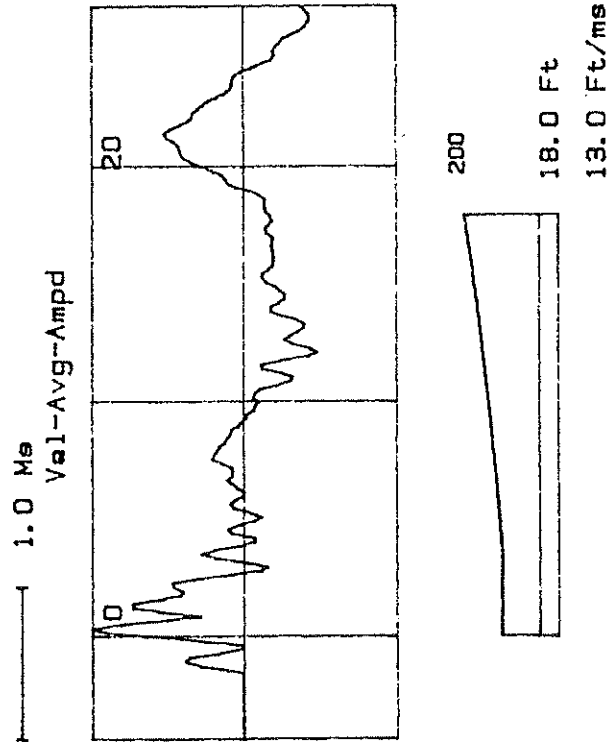
The velocity record shown in Figure 9 is for a 42 inch diameter drilled shaft with a reported length of 18 ft. As can be seen from the picture, four relatively large dowel rods were cast

The velocity record showed a strong toe reflection which means that it is, at least, continuous. A slight impedance decrease was noted at approximately 8 ft. The high frequency input (impact) was attributed to the high steel content near the pile top.

Later, the upper portion of the shaft was exposed. Inspection showed that indeed, there was a significant decrease in cross sectional area at approximately 9 ft. (reinforcement was exposed). More interesting, however, was the profile near the pile top. As shown in the picture, there are many significant cross sectional area changes within the top 5 ft. The high frequency impact, which was initially attributed to reflections from the high steel content, was after all, showing reflections from these cross sectional area changes.
