Large-scale dynamic high-strain load testing of a bridge pier foundations

ABSTRACT: The dramatic failure of a drilled shaft foundation resulted in the structural collapse of two bridge spans during the construction of a 5.2 km long viaduct in Central Florida, USA; shaking confidence in the 204 bridge pier support shafts already installed before the failure. A team of engineers conducting an independent forensic and remedial engineering study dynamically tested twelve completed bridge piers representing the varied geotechnical conditions along the bridge alignment. The 5 to 18 m tall structural piers were each supported by a single, 1.8 m diameter drilled shaft ranging in length between 13 and 30 m. The team performed high-strain dynamic load tests on top of the completed piers using a hydraulic hammer system with a ram weight of 534 kN and drop heights up to 1.9 m. Dynamic test instrumentation consisted of eight strain transducers and eight accelerometers, four each affixed near the pier bottom and the shaft top. Field data acquisition and initial processing were performed by means of two Pile Driving Analyzer[®] (PDA) systems, one each for the pier and shaft instrumentation. Pier

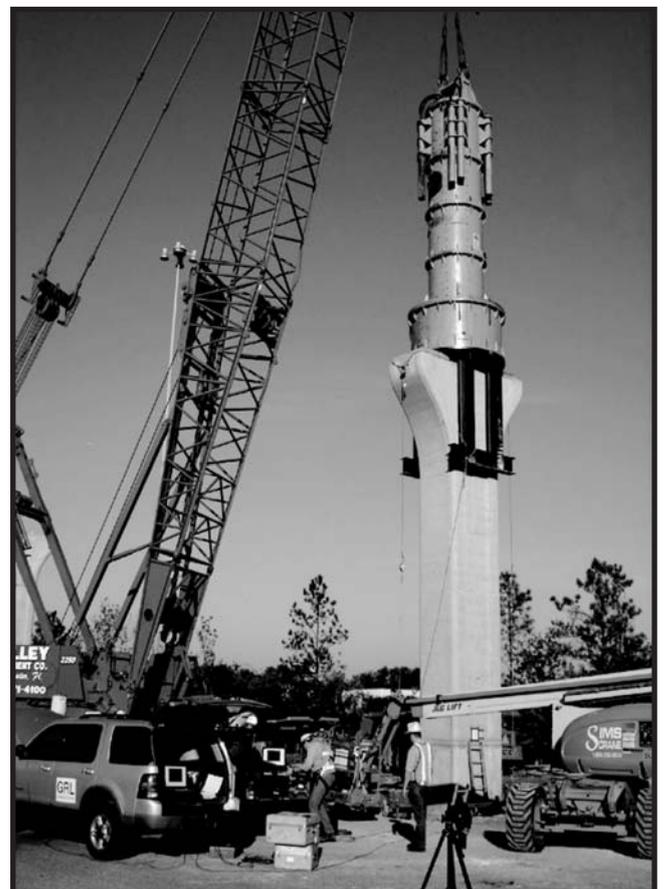
Figure 2. View of hammer on pier.

The special circumstances of this project included large-scale dynamic load testing of drilled shafts under existing bridge piers, relatively high capacities, and a heavy loading system. A total of twelve 1.8-meter diameter shaft/piers were tested, ranging in lengths between 13 and 30 m, supporting piers ranging in height between 5 and 13 m. The loading system was an American Piledriving Equipment APE-750U hydraulic hammer (Heller, 2004). It has a 534 kN (60 tons) ram and a maximum drop height 1.9 m (6.25 ft). Based on the above rule-of-thumb, the hammer would be expected to mobilize capacities up to between 27 and 54 MN. Fig. 2 shows a typical view of the hammer on top of a pier.

Engineers used the GRLWEAP wave equation program to evaluate the dynamic compatibility of the hammer-pier-shaft system, design a hammer cushion, striker plate, and pier-top cushion to control the tension and compression stresses induced in the pier and its shaft foundation. The hammer cushion consisted of a nylon disk with a thickness of 150 mm and a diameter of 1.14 m. It rested on a 400 kN steel striker plate, 910 mm m

thick and a diameter of 2.67 m. The plywood cushion used to protect the pier top had a thickness of 150 mm with an area of 2.09 m² sized to fit just inside the pier's steel reinforcement. A special pier-top straddle was constructed using steel I-beams that allowed the safe use of the hammer without leads for testing. The following discussion focuses on the results of two particular shaft/piers, designated here as Shaft A and Shaft B.

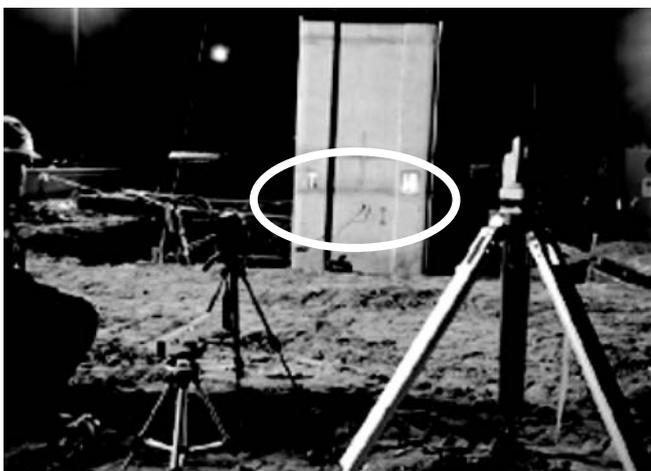
Figure 3. Pier instrumentation.

The shafts had nominal diameters of 1.83 m, and the piers had a nearly rectangular cross-sectional size of 1.52 by 1.83 m. An approximately 2 by 2 m square cap with a thickness of 0.6 m was cast between the top of each shaft and bottom of pier at the ground surface. An approximately 2 m deep excavation was dug around each shaft to provide access for visual inspection and instrumentation. Dynamic testing instrumentation consisted of eight strain transducers and eight accelerometers, four each affixed to the four sides of the pier at 1.5 m above the top of the cap, and four each affixed to equidistant locations around the circumference of the shaft top 1.5 m below the bottom of the cap. The pier and shaft instrumentation are shown in Figs. 3 and 4, respectively. Two PDA units were employed, one each for the pier and shaft gages. Dynamic stresses in the pier were monitored closely during the tests to check bending stresses and preserve the integrity of the pier concrete. Displacement following each hammer impact was measured near the bottom of the pier by using surveyors' instruments aiming at two faces of the pier, a wireline with mirror and scale, and a simple laser-and-target system. The pier response was also recorded by video camera.

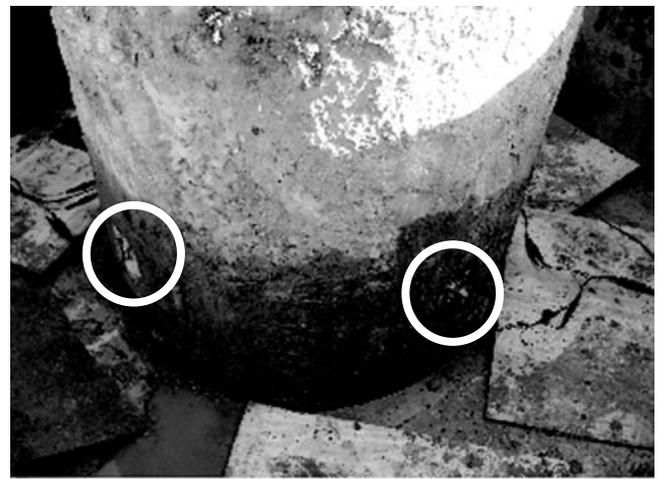
Figure 4. Shaft instrumentation.

Shaft A had a length of 22.5 m and supported a 6 m high pier. Measurement of shaft circumference at the gages location, i.e., 1.5 m below shaft top at bottom of cap, indicated a cross-sectional area of 2.85 m² (i.e., 1.9 m diameter). Shaft B was 18.8 m long supporting an 11 m high pier. Measurement of shaft circumference at the gages location, i.e., 1.5 m

below shaft top, indicated a cross-sectional area of 2.86 m² (i.e., 1.9 m diameter). In both cases, the cross-sectional area at the pier gage locations was 2.62 m², 9% smaller than the shaft top but different in shape. A stresswave speed value of 3800 m/s, with corresponding elastic modulus of 32 GPa, and a material unit weight of 23.6 kN/m³ were used in the processing and analysis of the dynamic test data.
