Empirical Assessment of Base Material for a Drilled Pipe Pile

FEATURE ARTICLE

Project Description

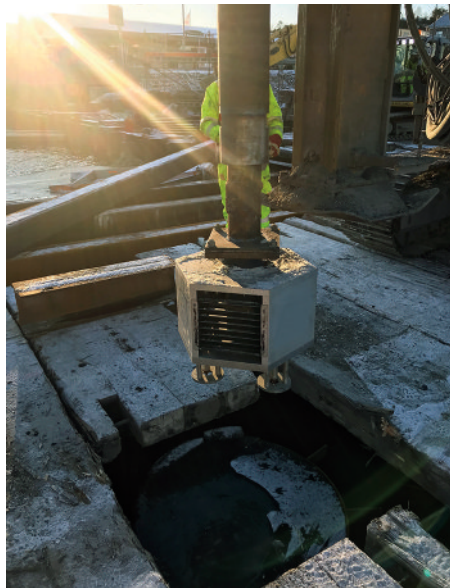
Attachment of the device to the end of a drill string

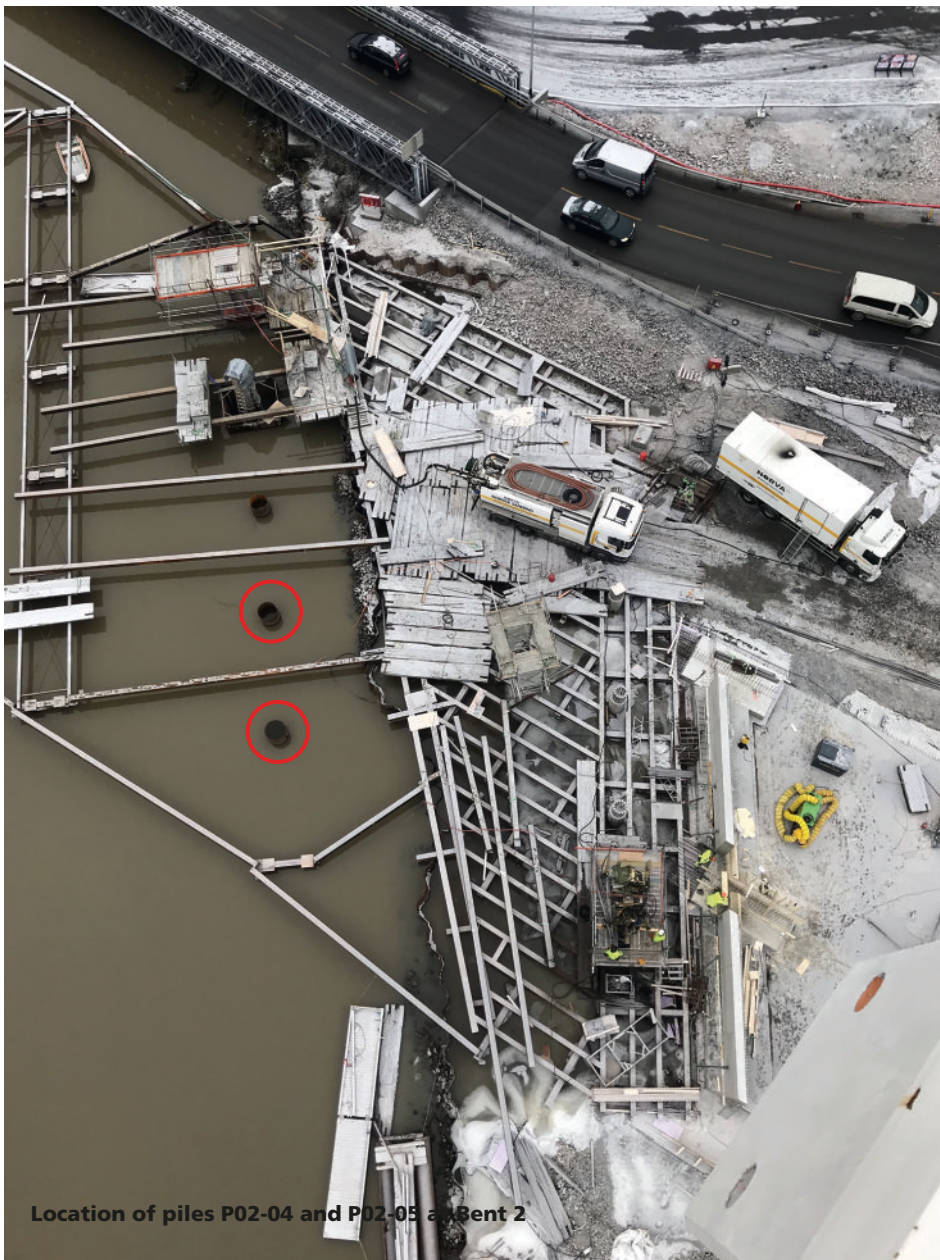
Location of piles P02-04 and P02-05 at Bent 2

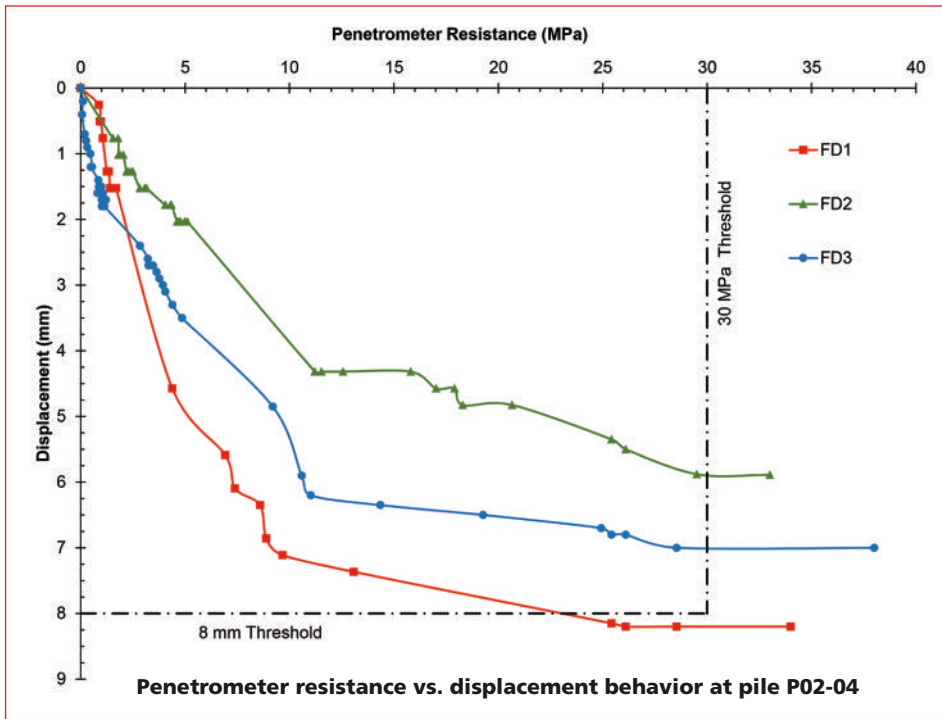
Penetrometer resistance vs. displacement behavior at pile P02-04

foundation was not completely flat. Furthermore, according to the plotted results, the average stress and displacement for the material at the base of the foundation were determined to be 35 MPa (5.1 ksi) and 7 mm (0.28 in), respectively. These values were within the established resistance and displacement thresholds for the competent material at the base of the foundation.

It is important to note that FD1 plot slightly exceeds the displacement threshold limit of 8 mm (0.32 in) with a stress value of about 24 MPa (3.5 ksi) and a maximum stress of 34 MPa (5 ksi). However, the other two plots (FD2 and FD3) are within the established threshold values. Another important observation is

the similarity in the shape of the relationships from the start of the test up to approximately 10 MPa (1.45 ksi) where a steady increasing slope is observed. Beyond this point, the relationships transition to a more constant and gentler slope with increasing stress, which may indicate an abrupt change in material property possibly indicating going from softer rock to more competent rock. However, a visual inspection using a down-hole camera, as discussed above, did not reveal softer material accumulated near the base of the foundation. Therefore, the existence of a softer rock versus a more competent rock is more likely to be the case at this location.

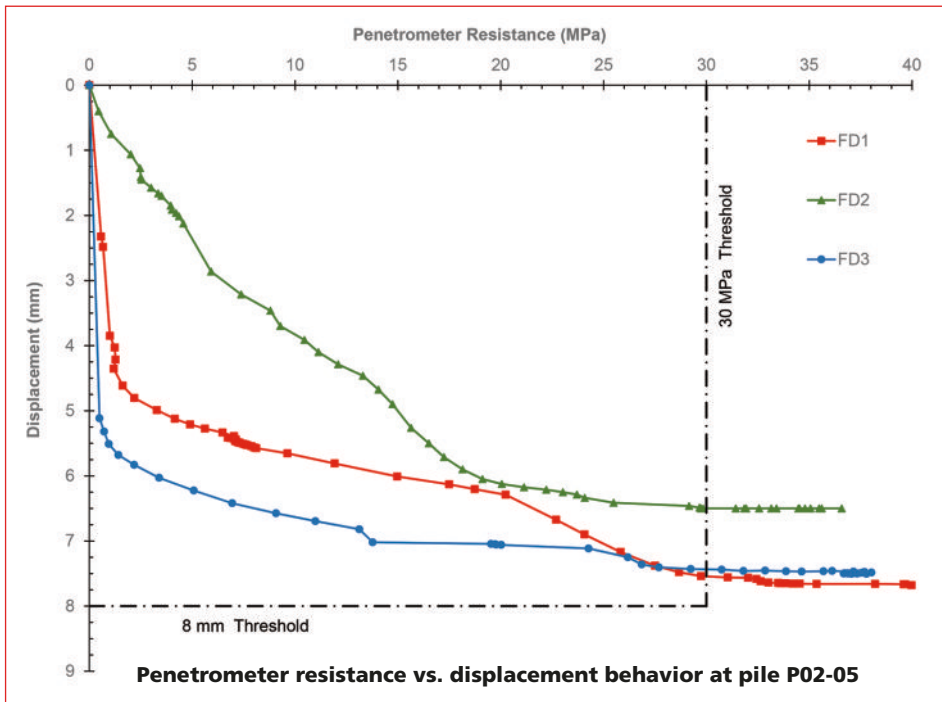
Penetrometer resistance vs. displacement behavior at pile P02-05

penetrometer and the corresponding displacements, the average stress and displacement for the material encountered at the base of the foundation were determined to be about 38 MPa (5.5 ksi) and 7.2 mm (0.28 in), respectively.

It is important to note that trend of FD2 is different compared to FD1 and FD3. The relationship for FD2 indicates a linear behavior with a constant slope up to a stress value of approximately 20 MPa (2.9 ksi) when the abrupt change of slope occurs. From this point forward, the relationship

flattens to an almost zero slope with increasing stress along with a very small change in displacement. The relationships for FD1 and FD3, on the other hand, follow a similar shape to each other and can be divided into three segments: (1) a steep slope from a stress of 0 to about 1.7 MPa (0.25 ksi), then (2) a small slope between 1.7 MPa (0.25 ksi) and 29 MPa (4.2 ksi), and then (3) a near zero slope after 29 MPa (4.2 ksi). The first portion of these plots could correspond to a very soft material accumulated at the base of the foundation,

which is then followed by a material with higher strength (e.g., weak or weathered rock). The third segment is where the abrupt change occurs similar to FD2 and the graphical relationship (similar to pile P02-04) indicates the existence of competent material or rock that satisfies the established criteria.
