FOUNDATION BASE MATERIAL STRENGTH ASSESSMENT FOR DRILLED PIPE PILES USING FORCE AND DISPLACEMENT DATA

ABSTRACT

PROJECT DESCRIPTION

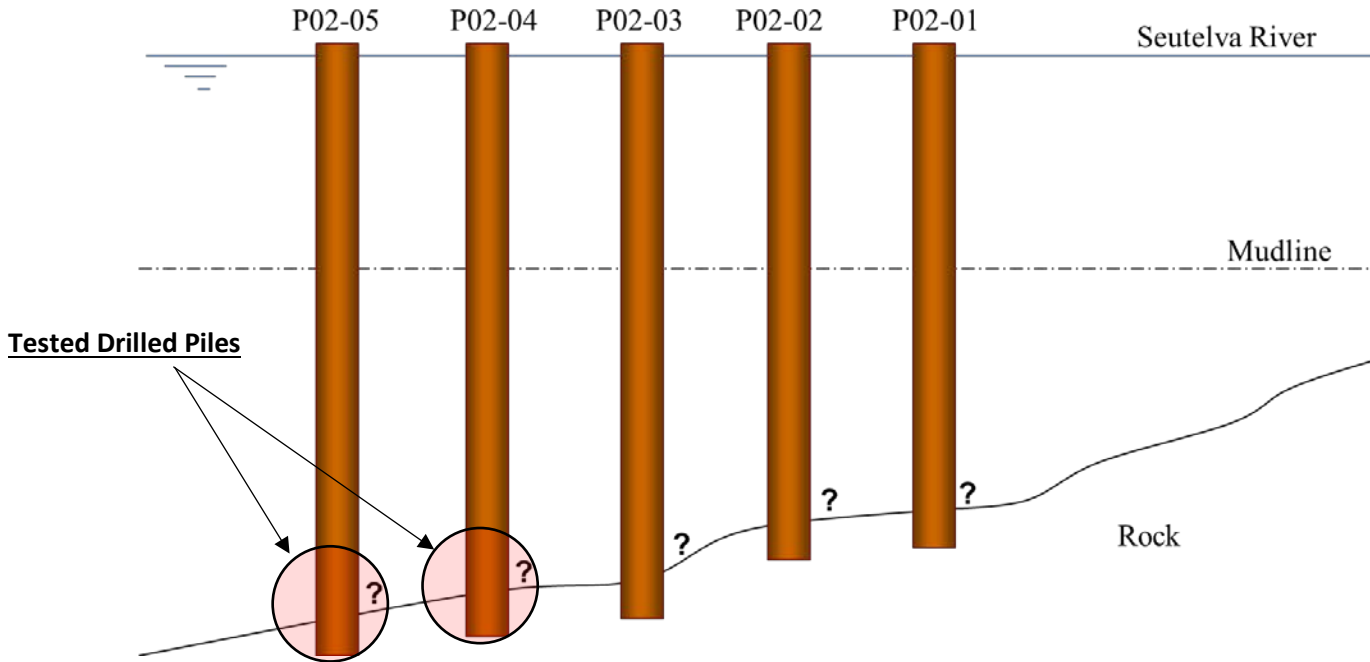
Figure 3. Schematics of base elevations for Bent 2, P02-01 to P02-05

The foundation system for the project presented in this manuscript was designed as end-bearing only where all nominal loads are supported by the foundation's base. However, due to difficult subsurface conditions and the sloping rock, each drilled pile had to be installed at a different base elevation, Figure 3. The criteria that was followed to decide the final base elevation consisted of several parameters with primary focus on (1) drilling advance rate: 40min/m minimum which corresponded to approximately a limit base resistance of 150MPa (22ksi), and (2) visual inspection with a down-hole camera. Considering uncertainties associated with the rock elevation, the contractor had to continue drilling until encountering a material that took approximately 40 minutes or more to advance 1m (3.28ft). Once the elevation was defined using the drilling rate data, the base of the drilled pile was cleaned using an airlift system, and a down-hole camera was lowered to inspect the bottom of the pipe to ensure full contact with the rock layer.

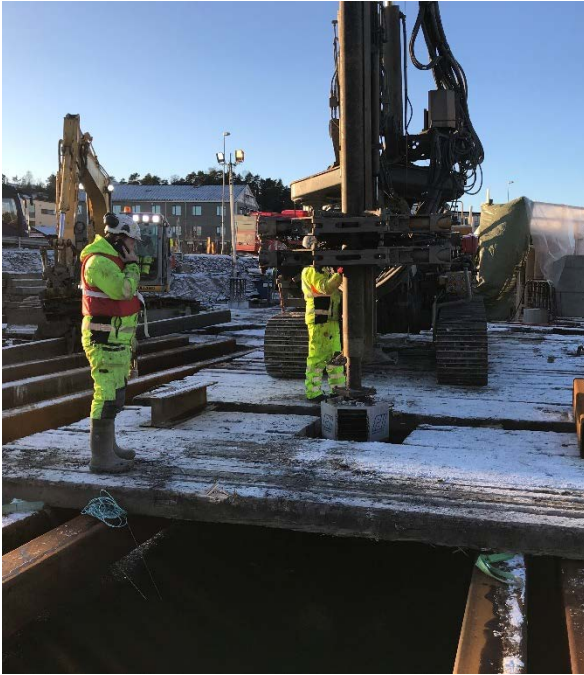
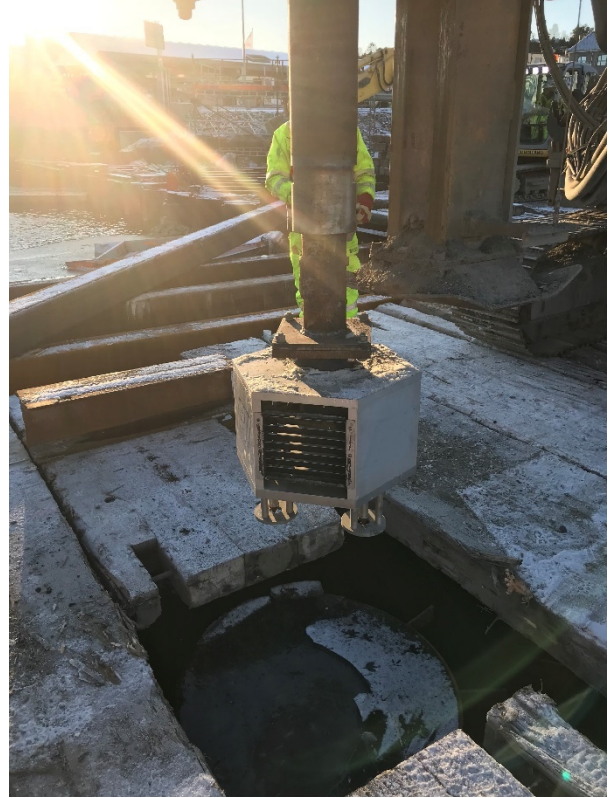
Figure 4. Testing procedure for Bent 2, Drilled Pile P02-05

The SQUID device was attached to the drilling strings using an American Petroleum Institute (API) adapter located between the swivel plate and the drill string and lowered into the drilled pipe to initiate test runs at the foundation base, Figure 4. Once at the base, axial force was applied using the drill rig crowd and the resistance to penetration was measured by the penetrometers, whereas measured displacements were determined by retractable plates.

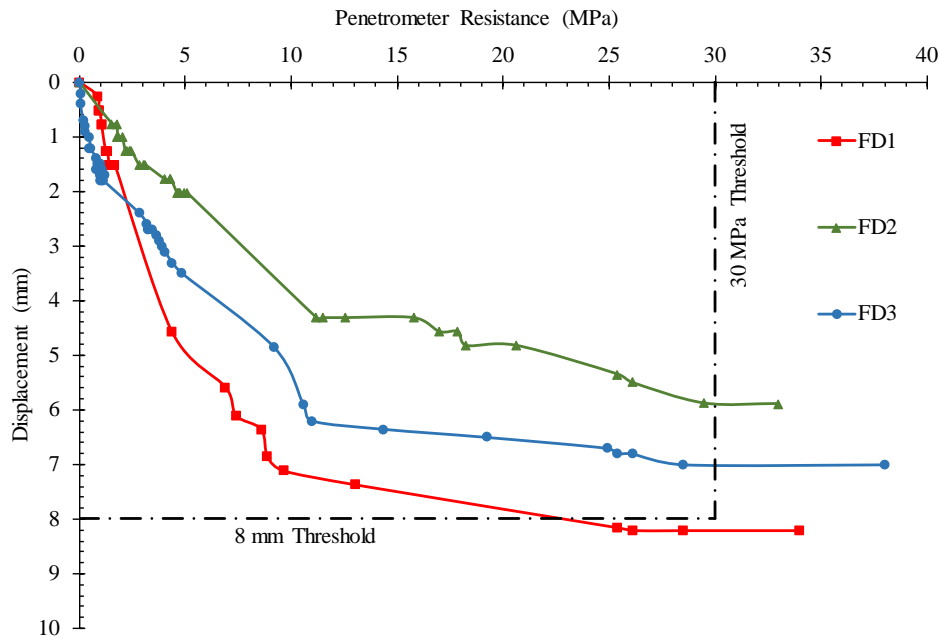
Figure 5. Average stress-displacement at the bottom of the Drilled Pile 02-04

A total of 10 runs were completed at the base of the drilled pile P02-04 obtaining force-displacement data. All applied forces were then divided by the penetrometer cross-section area to obtain applied stresses. Stress-displacements plots for the Pile02-04 were plotted individually to observe the criterion established for the material at the foundation base. Results obtained for Pile02-04 showed that all three penetrometers follow a similar trend. However, the nonuniform (i.e., not overlapping) plots behavior indicated that the foundation base was not completely flat. Furthermore, according to the plots, the average stress and displacement for the material at the foundation base were registered to be 35MPa (5.1ksi) and 7mm (0.28in). These values were within the establishes resistance and displacement for the competent material at the foundation base. Figure 5 illustrates the average stress-displacement plot for the runs at the base of pile P02-04. Note that FD1 plot is slightly passing the threshold limit of 8mm (0.32in) with a stress value of 24MPa (3.5ksi) and a maximum stress if 34MPa (5ksi). However, the other two plots are within the established threshold. Another important observation is the shape of the plots from the start or the test up to approximately 10MPa (1.45ksi) where a steady increasing slope is observed. Beyond this point, the plots start to have a more constant and gentler slope with increasing stress which

could be indicating an abrupt change of material property going from softer rock to more competent rock. However, a visual inspection using a down-hole camera showed no softer material accumulated nearby the penetrometers. Therefore, the existence of a softer rock versus a more competent rock is more likely to be the case.

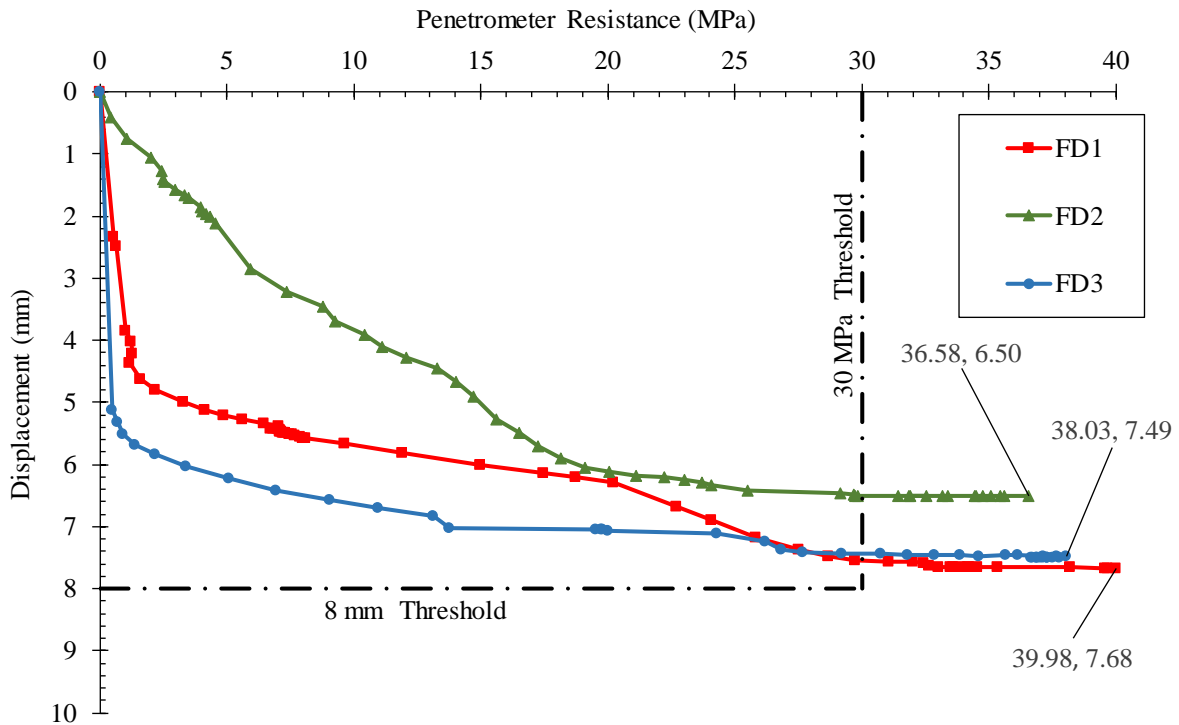
Figure 6. Average stress-displacement at the bottom of the Drilled Pile 02-05

A total of 13 runs were completed at the base of the drilled pile P02-05 and similar to the previous pile, stresses at the foundation base were determined by dividing measured forces by the penetrometers cross-section area. Stress-displacements plots were individually analyzed to observe the criterion established for the foundation base material. Results showed that all three penetrometers follow a similar trend, specially toward the end of the test. Similar to the previous test, a nonuniform foundation base material was detected since the plots are not overlapping. Considering each maximum stress registered by each penetrometer and their corresponding displacements, the average stress and displacement for the material encountered at the foundation base were registered to be 38MPa (5.5ksi) and 7.2mm (0.28in), respectively. These values were within the established resistance and displacement for the competent material at the foundation base. Figure 6 illustrates the average stress-displacement plot for the runs at the base of the pile P02-05. Note that FD2 trend is different compared to the other two plots (i.e., FD1, and FD3). The FD2 plot shows a linear behavior with a constant slope up to approximately 20MPa (2.9ksi) when the abrupt change of slope occurs. From this point forward, the plot turns to an almost zero slope

line with increasing stresses and very small change in the displacement. The other two plots on the other hand, follow the same shape and can be divided into three segments: (1) a steep slope from 0 to 1.7MPa (0.25ksi), (2) small slope between 1.7MPa(0.25ksi) and 29MPa (4.20ksi), and (3) zero slope line after 29MPa (4.20ksi). The first portion of these plots could correspond to a very soft material accumulated at the foundation base followed by a material with higher strength (e.g., weak or weathered rock). The third segment is where the abrupt change occurs similar to FD2 and plots corresponding to P02-04 indicating the existence of competent material or rock that meets the established criteria.
