THE KEY AT 1100 BROADWAY

BY CHARLIE BOWER, CASE PACIFIC

SITE HISTORY

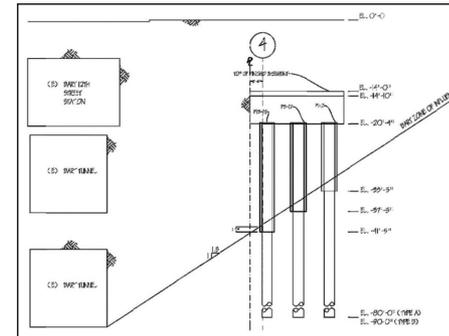
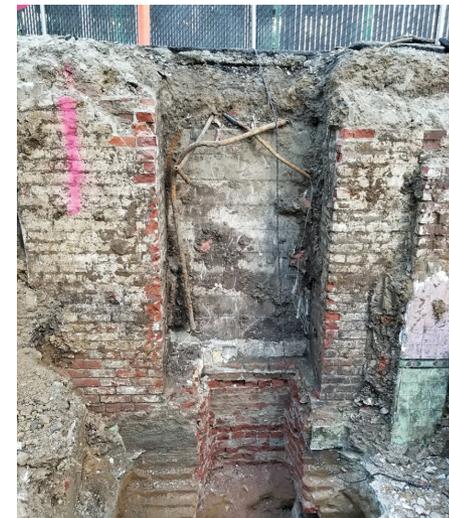
NOTCHES DUG INTO EXISTING BRICK WALLS TO FACILITATE

left from previous excavations and BART

SOLDIER BEAM INSTALLATION

With land costs at a premium, the intent is to squeeze every inch out of the existing square footage of property. Our shoring system was installed beyond property lines though old brick and concrete walls left behind from a pre-existing basement. Due to the manmade subsurface conditions, construction of the shoring system from grade was an everyday surprise. To minimize impacts, slot cuts were excavated perpendicular to existing basement walls with selective demo performed to remove brick, concrete and old backfill

construction. Following the installation of beams, lagging was installed as the brick walls were demolished lift by lift, leaving the face of our beams at property line and the future removal of the beams to five feet below-grade still to come.

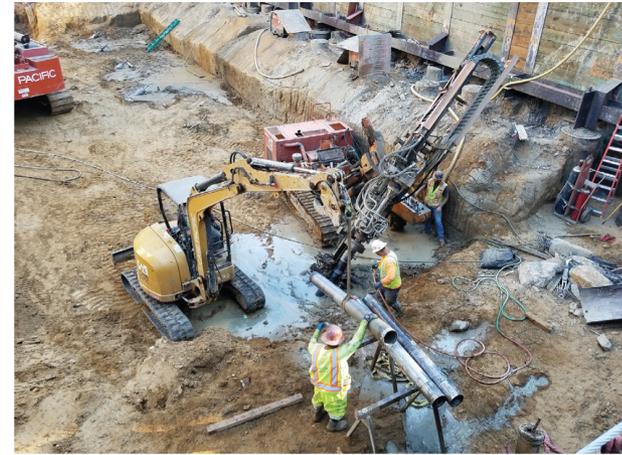
INSTALLING VERTICAL AND BATTERED MICROPILES FOR THRUST BLOCKS

one means of preventing lateral movement to meet the criteria required. The entire Broadway side had to be internally braced. A total of nine each of raker beams found their way down into an equal number of thrust blocks, each of which housed three each of 200 to 320-kip micropiles, two battered (one on top of the other) and one vertical. These had to be constructed at a higher elevation than anticipated due to the shallow nature of the upper row of battered micropiles, otherwise placing the mast of the drill rig within the newly constructed shoring wall just 20 feet away.

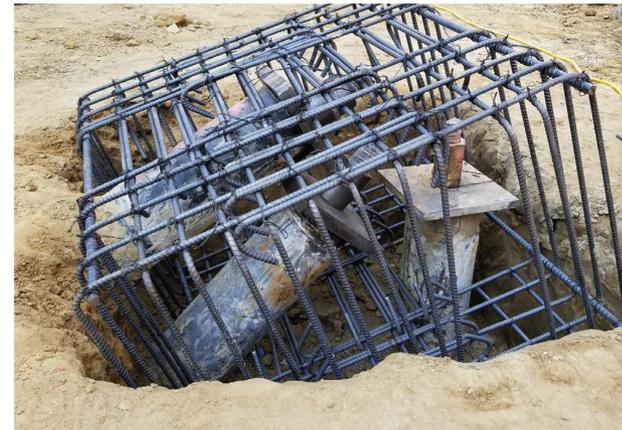
COMPLETED THRUST BLOCK READY FOR FORMING AND POURING

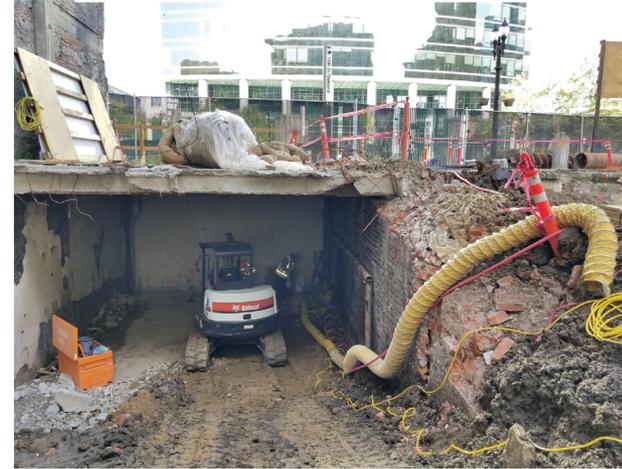
EXISTING KEY BUILDING BASEMENT WALL AND DIAPHRAGM LEFT INTACT UNTIL BRACING AND UNDERPINNING PITS WERE IN PLACE

Adding to the issues along Broadway was the existence of an old basement in the Key Building. This basement not only sat beneath the existing seismically unsound structure, but also extended 20 feet beyond the building into the site of the new construction. The basement wall separated the new project site and old Key building basement. The old basement wall was being surcharged on the new project site side and the old brick wall only being supported by the basement roof slab acting as a diaphragm. Removal of this wall would require equalizing loading on both sides. Because this was not possible, the existing basement wall and the wall

to be braced and underpinned from within the existing basement. Once completed, they could later be tied into the balance of the west side shoring prior to the demolition of the diaphragm.

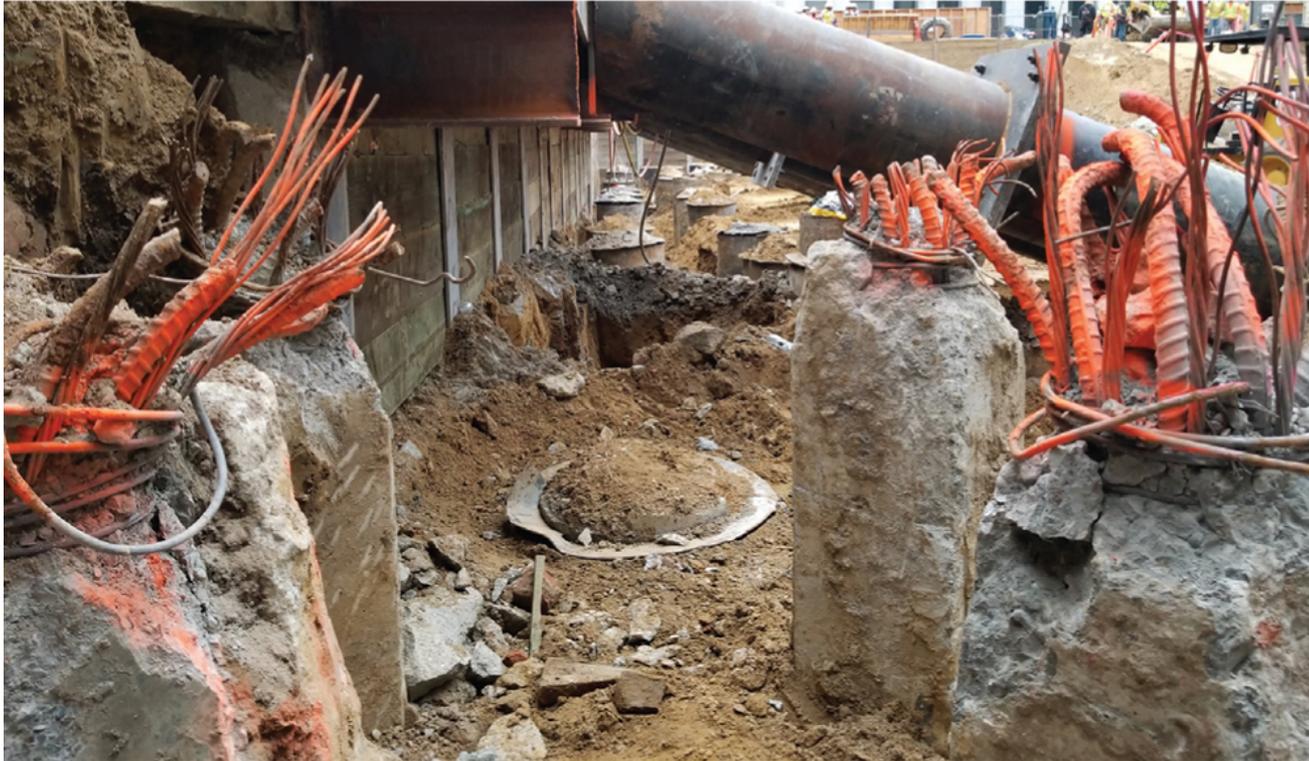
The design of “The Key” features a cantilevered upper section that overhangs the old Key building, then extends up to its new top 18th floor. Due to this load, the building required additional 24-inch, double-cased piles and a series of thickened mat slabs with 19 eight-inch diameter ground improvement piles with 400-kip capacities for additional support. These ground anchors sat at the lowest elevation of the job and were the last scope of work performed prior to digging ourselves out of the hole.

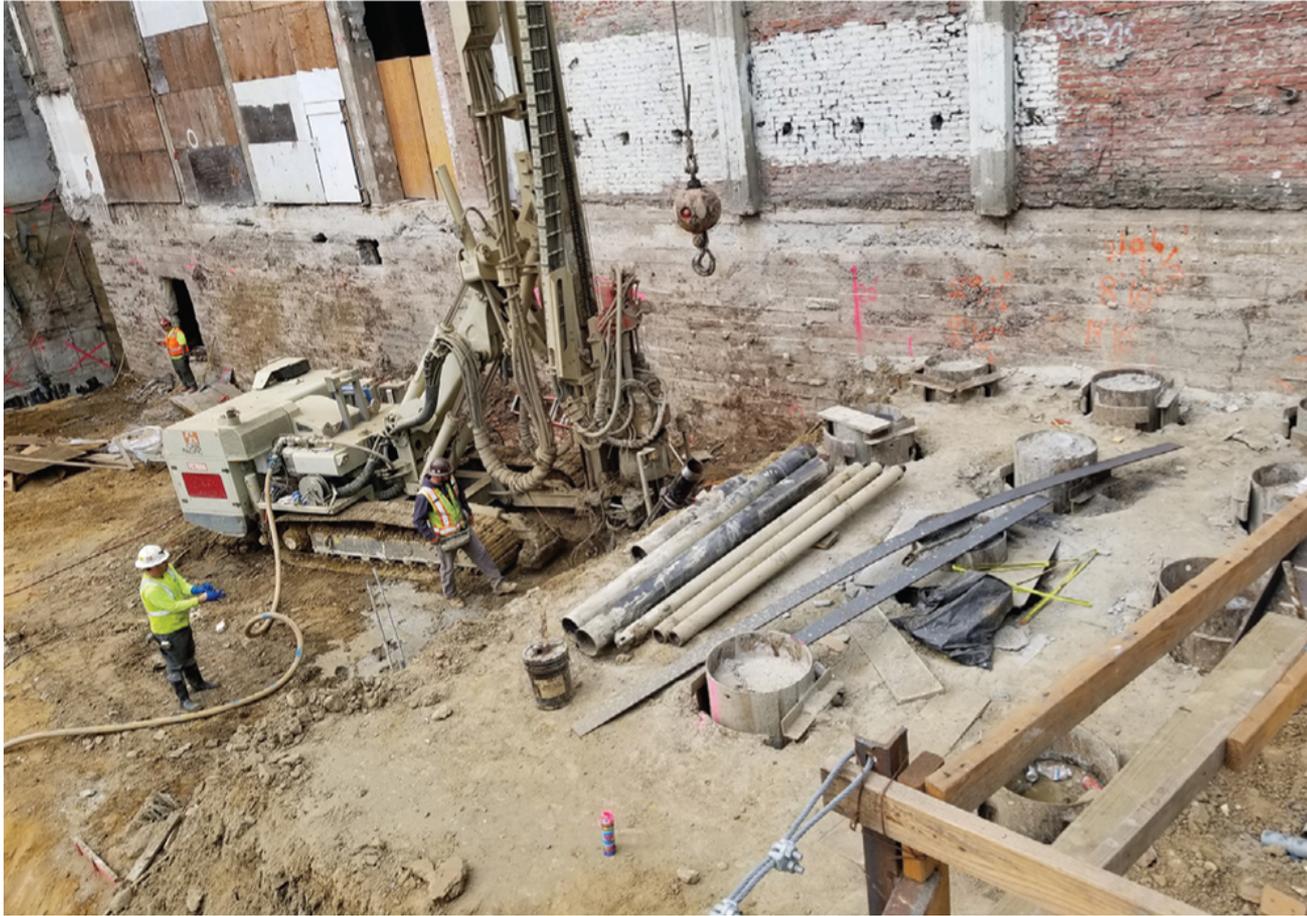
INSTALLATION OF GROUND IMPROVEMENT MICROPILES
