## **Structural Evaluation of Thermal Integrity Profile Results of Transmission Foundations**

Travis Coleman, P.E., GRL Engineers, Inc, Lincolnwood, IL, (847) 213-0592, [tcoleman@grlengineers.com](mailto:tcoleman@grlengineers.com)

Ryan Weaver, P.E., Burns & McDonnell, Chesterfield, MO, (314) 682-1555, [rjweaver@burnsmcd.com](mailto:rjweaver@burnsmcd.com)

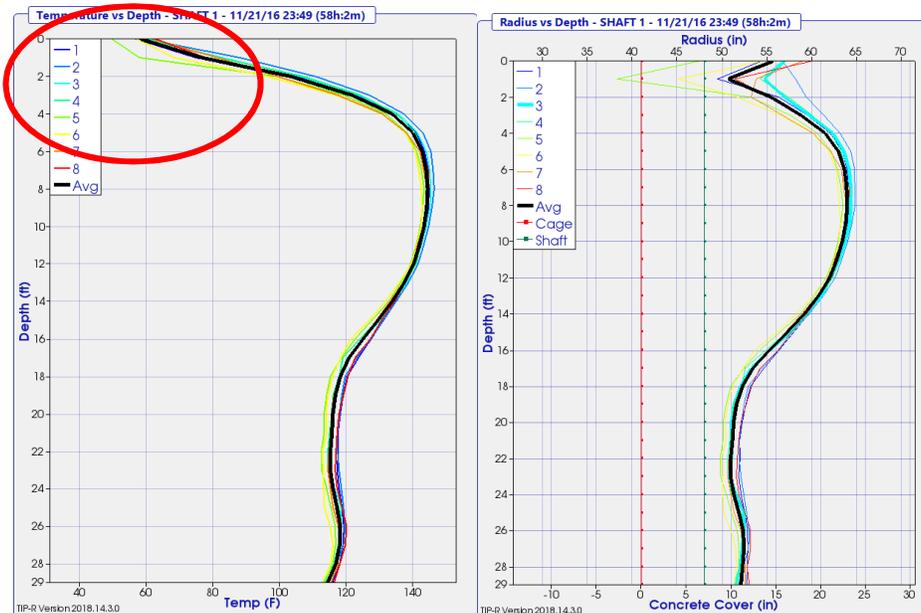
**Fig. 1 and 2 – Shaft 1 Temperature and Effective Radius versus Depth**

Figures 1 and 2 show a typical TIP result for a shaft without significant issues. The average radius is greater than the nominal radius over the full shaft length, with a bulge apparent in the upper portion of the shaft near the ground surface. This is typical, with oversized casings often used near the ground surface along with repeated passing of the drilling equipment during excavation. A close review of the upper 2 ft would indicate that one wire has an anomalous effective radius which is less than the cage radius 1 foot below the shaft top. The upper roll-off correction is applied to the average shaft temperature. Thus, any slight elevation changes in the first embedded node, which are circled in the temperature vs. depth figure, are exaggerated within the changes in boundary condition occurring in the shaft reveal. This limitation of the TIP results should be noted, along with a recommend to visually inspect the shaft top.

Owner's Engineer Comments: For this installation, it was apparent that the installed dimensions of the foundation were larger than the design dimensions. No further discussion was warranted for this foundation.

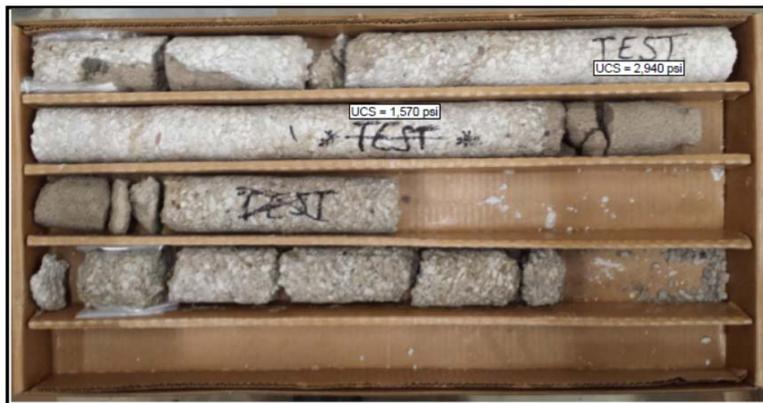
**Figure 6 - Shaft 2 Core Results**

A core was advanced outside of the bolt ring for this shaft. The core indicates concrete with sand lenses were encountered beginning at 25 ft below the shaft top. The final approximately 7 ft of the core are shown in Figure 6 below, with low concrete breaks, sand seams, and unrecoverable sections.

Owner’s Engineer Comments: Based on the TIP analysis and the follow-up rock coring, the design engineer further reviewed the foundation design based on revising the pier depth to be the estimated depth at where the concrete contamination became apparent, while also allowing for the larger as-constructed diameter to be included. A 9 ft diameter X 26 ft length pier design was evaluated where the initial design was for 8.5 ft diameter X 31 ft length. It was found that the revised design presented did not appear to meet the serviceability requirements (i.e. displacements), and applied loads were greater than design capacity. Ultimately the shaft was abandoned and re-drilled.
