## I-480 Valley View Bridge Pile Test Program

The widening of the I-480 Valley View Bridge was a design-build project for the Ohio Department of Transportation (ODOT), with Walsh Construction as team lead and general contractor, and Jacobs as lead designer. The design-build team chose to develop a design-phase pile test program to quantify the soil setup and include those findings into the final pile design.

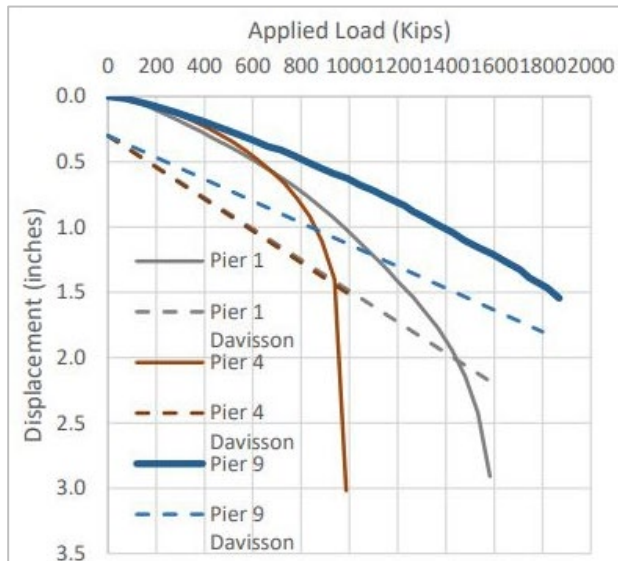
Figure 1. Applied Load vs Pile Head Movement for Three Static Load Tests

The static load tests provided up to 2000 kips. Geotechnical failure of the SLT piles occurred for two of the three piles presented below, while one SLT pile was loaded to the maximum load without failure. **Figure 1** depicts the load vs pile head displacement curves for all three static load tests. CAPWAP analysis for the long-term restrikes incorporated the results from the static load tests. The values from the t-z curves and internal force profiles were used to refine the resistance distribution in the analyses. For test piles at piers where a static load test was not performed, the resistance distribution was adjusted based on the force and velocity curves, but general trends in the resistance distribution were similar. The results from the instrumented static load tests indicated higher than anticipated unit shaft resistance values which were also present in the CAPWAP analysis.
