LOW STRAIN DYNAMIC TESTING OF WOOD PILES SUPPORTING AN EXISTING PIER

ABSTRACT

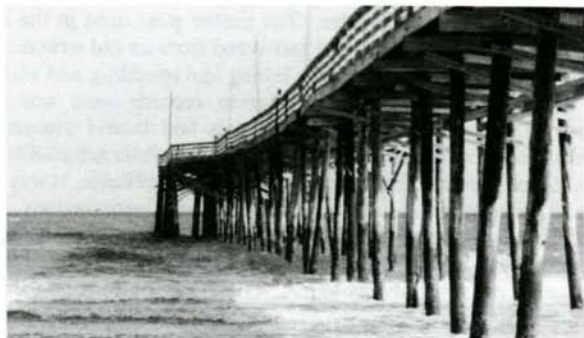
Figure 1: General View of Pier and Piles

structural distress caused by foundation settlements and lateral movements. The 183 m long pier is carried on 51 bents supported by a total of 124 timber piles. The number of piles in each bent range between 2 to 4 piles. The pier deck is approximately 6 m above water level. Water depth increased to a maximum depth of 7 m at the pier head. Subsurface conditions at the site consist of mainly loose to firm fine to coarse sand and gravel to a depth of 3 m under which a deep layer of very hard clayey organic silt occurs. Figure 1 shows a general view of the pier and its piles. The timber piles used in the construction of this pier had been used before and recovered from an old structure. All piles were installed, large diameter down, by jetting and spudding and without the use of a pile driving hammer. Pile installation records were not kept during construction. Differential vertical settlements and lateral movements of the foundation piles are adversely affecting the structure's functionality and risking its stability. Since pile installation records were not available, it was not possible to determine pile lengths in-place and conclude penetrations in order to rationally evaluate the foundation system. Visual inspection of the pile shafts indicated some deterioration, particularly within the tidal zone. One pile was totally broken. Low strain dynamic pile testing was performed for the purpose of assessing pile structural integrity and lengths. The information obtained was essential for evaluating the overall integrity of the structure and for developing a rehabilitation program.

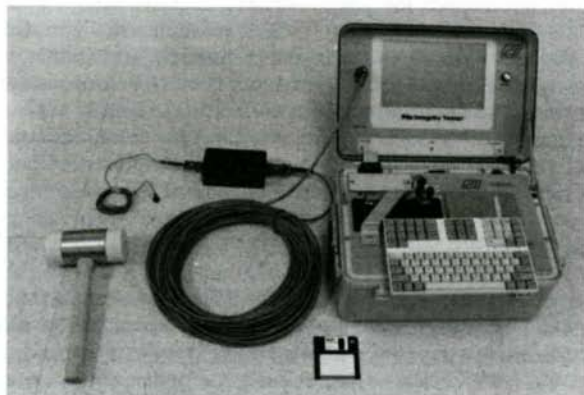
Figure 2: Pile Integrity Tester (P.I.T.) Equipment

Stress waves at the pile head are commonly monitored with an accelerometer. Field testing is conveniently performed using the Pile Integrity Tester (P.I.T.) system which consists of an accelerometer, a hand held hammer and a field data acquisition system capable of digitizing analog signals and processing digital data. The P.I.T. equipment is shown in Figure 2.

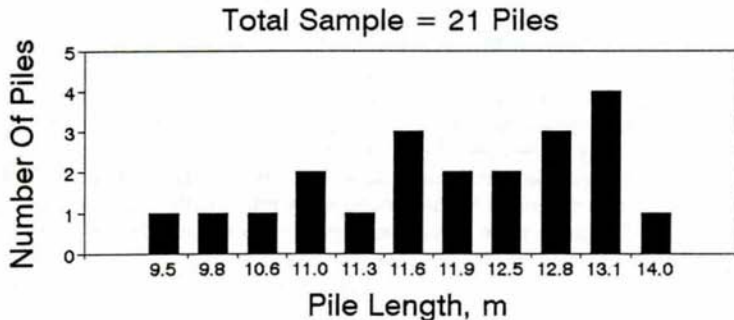
Figure 4: Summary of Testing Results

records as a function of length (time scale also indicated) for one pile under two hammer blows along with amplification factor used and data interpretation of length (12.5 m) assuming wave speed (4000 m/s). For the 21 piles tested, pile lengths ranged from 9.5 to 14.0 m. Figure 4 presents a summary of testing results. Data from some of the piles tested contained early wave reflections indicating reduction of pile impedance from locations coinciding with the water level. Visual inspection of the piles confirmed pile deterioration of suspected piles. Considering the distance between mud line, pile tops and lengths determined by dynamic testing for each pile, it was concluded that pile embedments were generally less than one meter into the ground.
