Geotechnical Aspects of Failures at Port-au-Prince Seaport during the 12 January 2010 Haiti Earthquake

Presented herein are the results of geotechnical investigations and subsequent laboratory and data analyses of the Port-au-Prince seaport following the M_w 7.0 2010 Haiti earthquake. The earthquake caused catastrophic ground failures in calcareous-sand artificial fills at the seaport, including liquefaction, lateral spreads, differential settlements, and collapse of the pile-supported wharf and pier. The site characterization entailed geotechnical borings, hand-auger borings, standard penetration tests, and dynamic cone penetration tests. The laboratory tests included grain size and carbonate content tests. The observations and results presented herein add valuable field performance data for calcareous sands, which are relatively lacking in liquefaction case history databases, and the overall response of the artificial fills are consistent with predictions made using semi-empirical relations developed primarily from field data of silica sands. [DOI: 10.1193/1.3636440]

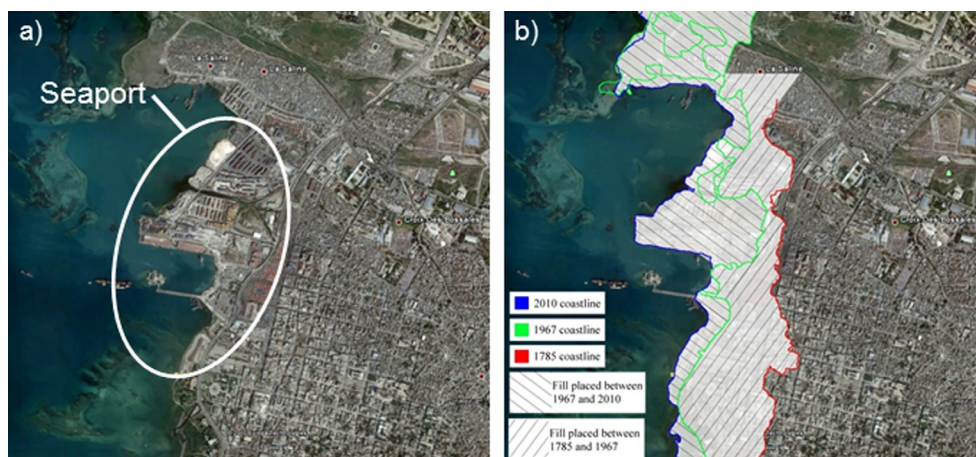
Figure 2. Aerial images of the seaport at Port-au-Prince: (a) Image taken shortly after the 12 January 2010 earthquake; (b) Same image shown in (a) with 1785, 1967, and present-day coastlines and artificial fill areas demarcated.

The coastlines of the port region in 1785, 1967, and 2010 are shown Figure 2, with the areas where artificial fill was placed being denoted (Ponce 1791, Army Map Service 1967, Google Earth 2010). The difference between the coastlines in 1967 and 2010 is mainly the result of fill being placed in 1976–1978 when the port was expanded. During this expansion, 28 acres of land were reclaimed from the sea. The 635,000 m^3 of hydraulic fill that was used to reclaim the land is composed mostly of calcareous sand and larger shell and coral fragments that were dredged from the harbor (Berniard 1978). The area in which the hydraulic fill was pumped was bounded by rock berms and a temporary dike. One to two meters of compacted gravelly fill was placed over the hydraulic fill, bringing the ground surface to its present elevation. It is unknown whether the hydraulic fill was densified, but it is doubtful given the SPT and DCPT blow counts (N-values) that were measured in the post-earthquake field investigations (discussed more in subsequent sections of this paper).

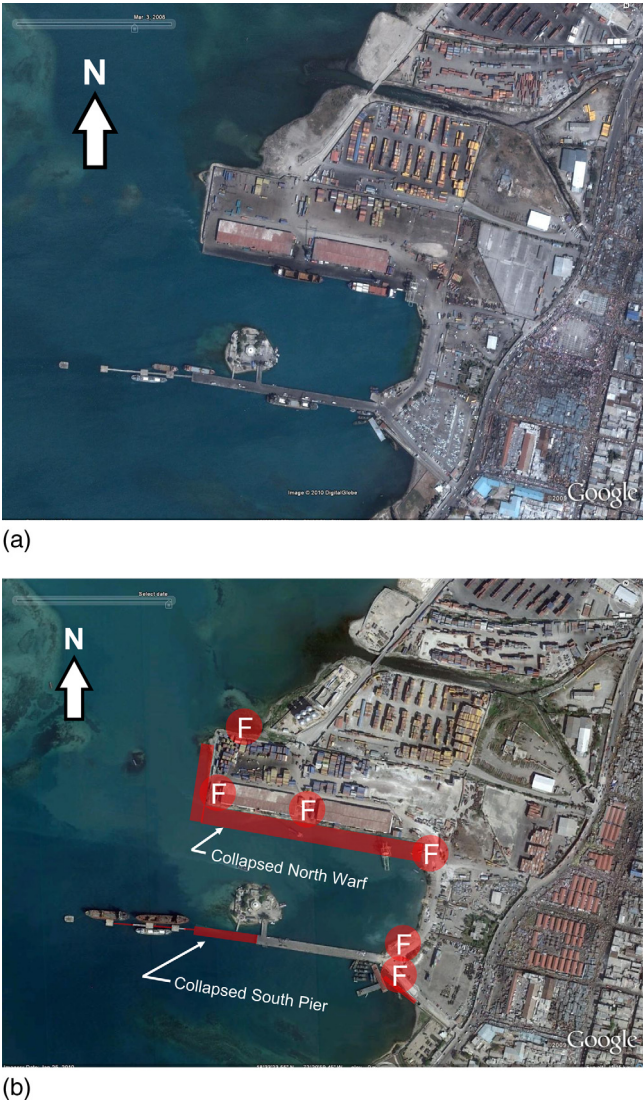
Figure 3. Aerial images of seaport at Port-au-Prince, (a) prior to earthquake; and (b) after the earthquake illustrating ground failures, marked with “F,” and damage to South Pier and North Wharf.

Pre- and post-earthquake aerial images of the port are shown in Figure 3. Light-colored areas on the ground surface in Figure 3b are sand boils and ejecta that were observed in the eastern half of the container storage yard and behind and between the two warehouses. The locations where large lateral spreading fissures were observed are also shown in Figure 3b. These images clearly show evidence of liquefaction and lateral spreading, collapse of the North Wharf, and collapse of portions of the South Pier. Damage to the South Pier is detailed in [Werner et al. \(2011\)](#) and is not discussed in detail in this paper.

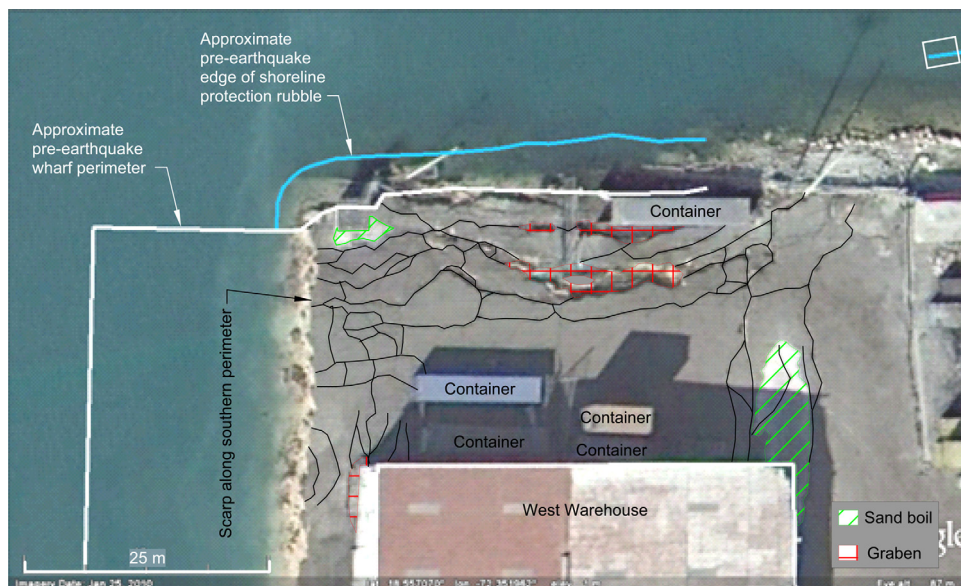
Figure 4. Aerial view and schematic of ground failure at western end of North Wharf. Pre-earthquake image dated 26 August 2009 used for pre-failure perimeter. Post-failure image taken on 13 January 2010. Manual survey performed on 1 February 2010. Warehouse width is approximately 37 m, with an additional 4 m overhanging roof on the north side of structure.

Figure 4 presents a schematic of the lateral spread that occurred along the western perimeter of the North Wharf's fill embankment. We measured a cumulative total of 2.6 m of lateral displacement, but this magnitude likely underestimates the actual maximum displacements at the original western edge of the wharf, as some of the displaced portion of the embankment flowed into the bay and was not accessible. Moderate lateral spreading also occurred along the northern perimeter of the wharf but was not measured.

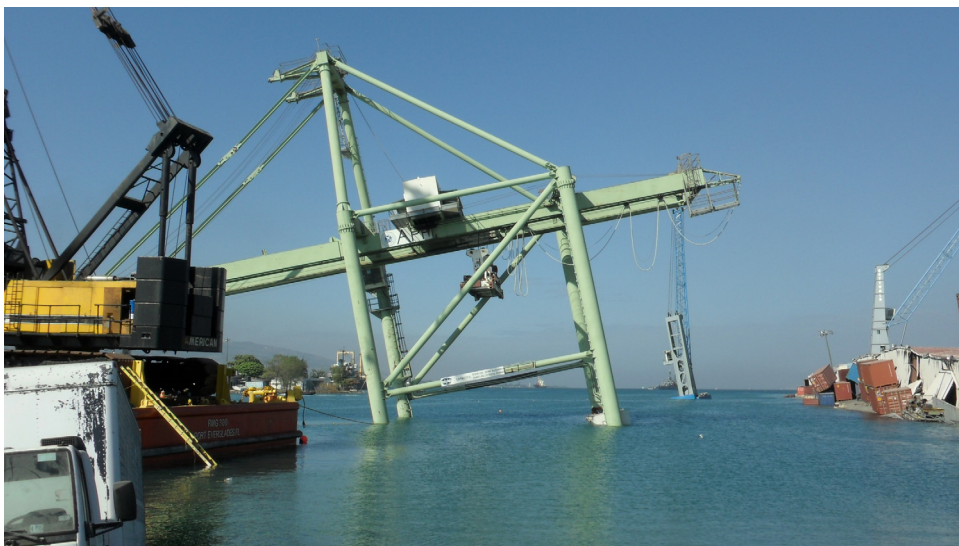
Figure 5. Submerged 15-m gauge container crane (foreground) and mobile crane (background).

The A-frame container crane and one rubber-tired crane displaced into the bay along with the concrete marginal wharf, rendering them inoperable, but they appeared to be undamaged. The second mobile crane was parked between the two warehouses and was undamaged. Figure 5 shows the A-frame container crane in the foreground and the partially submerged rubber-tired mobile crane in the background. Interestingly, a photo taken immediately after the earthquake from aboard a ship docked at the eastern end of the wharf (Figure 6) shows that the landside legs of the A-frame crane were still above water and near the easternmost end of its tracks, although the tracks had moved seaward about 2 m relative to the adjacent land. However, a U.S. Coast Guard photo taken during an over flight of the port at midday on 13 January 2010 shows the crane in the same position as in Figure 5 (i.e., moved westward about 50m west and about 15 m south from its position in Figure 6) and with the base of the crane fully submerged. The 13 January

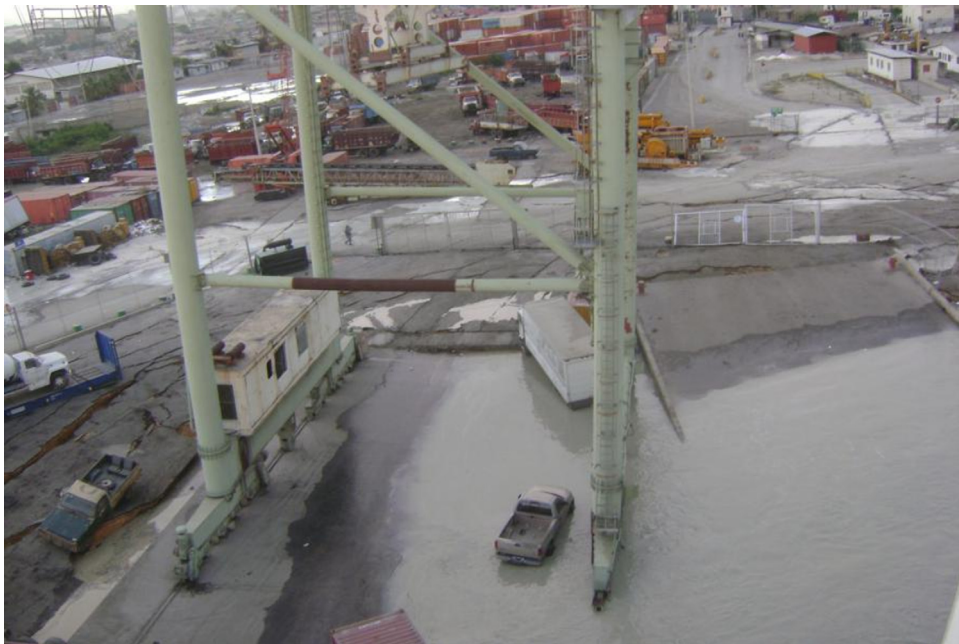
Figure 6. Photo taken immediately after the earthquake with the crane in its most eastward position and with the landside legs of the crane above water. Photo taken facing east. (gCaptain, 2010).

2010 photo also shows that additional subsidence occurred at the eastern end of North Wharf (i.e., the location of the crane in Figure 6). The National Earthquake Information Center reported that no fewer than 45 aftershocks ranging from M_w 4.0 to 6.0 occurred between the main shock and 1:54 pm EST on 13 January 2010 (Rathje et al. 2010). This suggests that a portion of the observed permanent displacements may have been caused by liquefaction that occurred as a result of aftershocks.

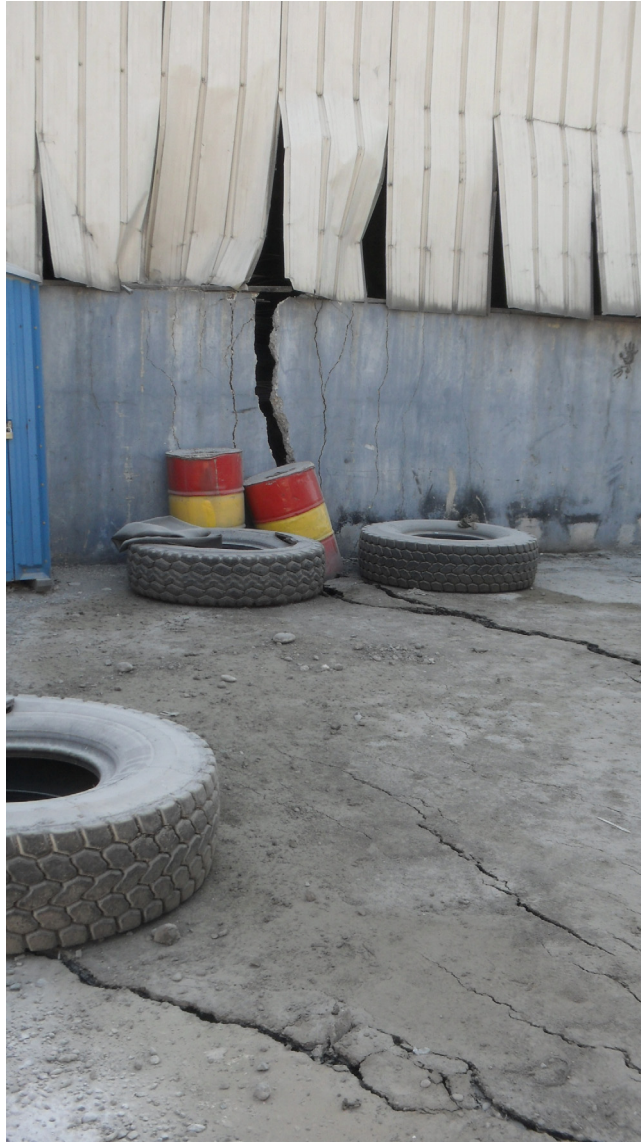
Figure 7. Lateral spreading crack extending into the western foundation wall of the west warehouse.

Significant damage to the steel warehouses along the southern half of the north wharf also occurred. As shown in Figure 7, lateral spreading cracks running in the east-west direction cut through each of the warehouses' foundation walls. A detailed survey of the settlements relative to the north edge of the western-most bay and lateral movements of the west warehouse slab are shown in Figure 8. The interior slab consisted of 14 separate slabs, two each in seven bays. Due to lateral spreading, the south wall (adjacent to the shoreline) moved approximately 0.7 to 1.4 m laterally towards the shoreline (i.e., the width of the warehouses increased). The settlements across the warehouse interior were variable, with the southern sections settling as much as ~ 0.8 m. It appeared that the warehouses were founded on strip footings around their perimeters, which settled significantly. Settlements measured at the adjacent inland corners of the warehouses were about 15 cm at the west warehouse (see Figure 8) and more than 40 cm at the east warehouse.

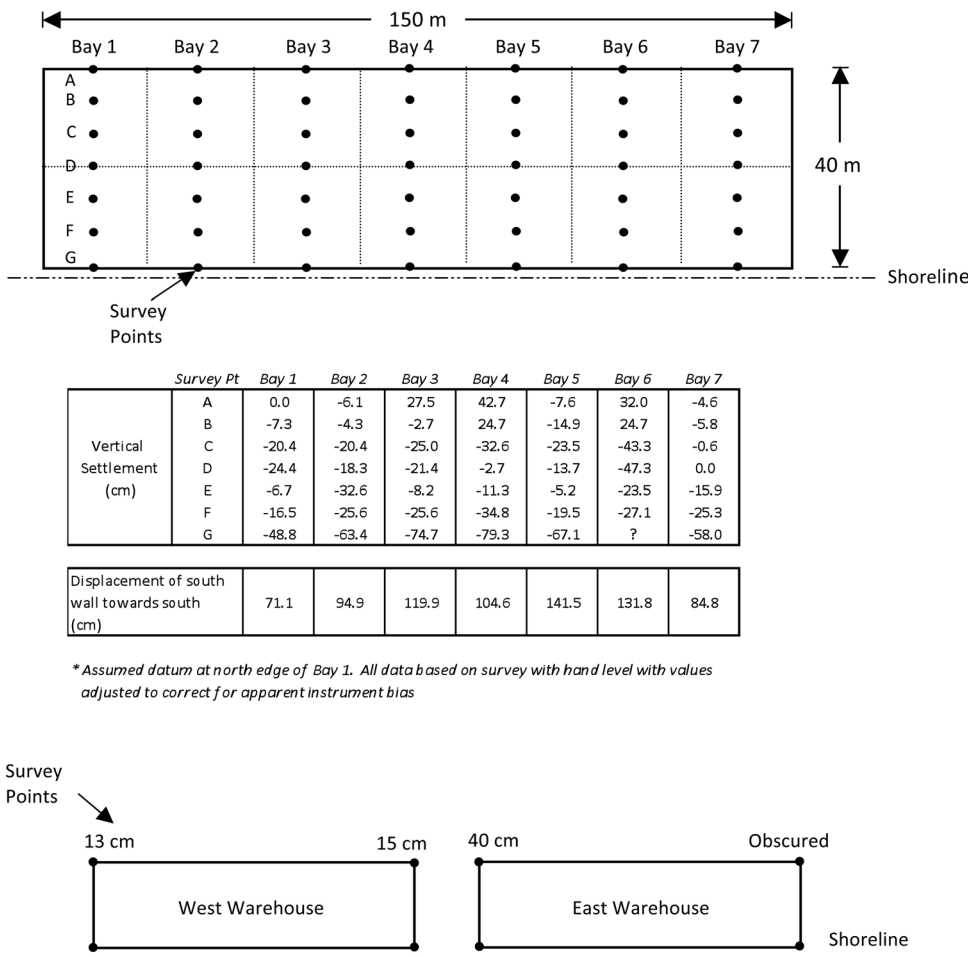
Figure 8. Results of a detailed survey of the relative settlement of the west warehouse slab and total settlement of inland corners and total lateral displacement of seaward side of west warehouse. All displacements inside warehouse measured relative to survey location in northwest corner of warehouse. Displacements at NW and NE warehouse corners indicate relative settlement of ground surface with respect to warehouse wall. Displacements along southern warehouse wall indicate lateral movement of wall with respect to floor slab.

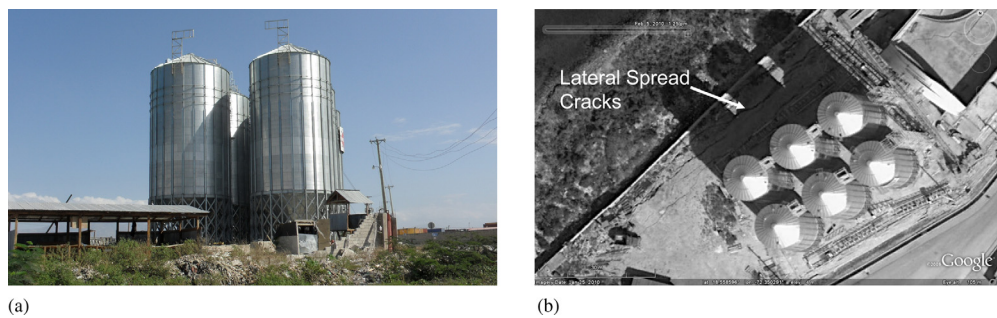
Figure 9. Steel grain silos north of the main seaport: (a) Photograph taken from the ground facing northeast; (b) aerial image of silos taken after the earthquake with lateral spread cracks demarcated.

North of the main port facility along the shoreline, there were six steel grain hopper silos and two storage yards (Figure 9). Construction of the grain silos started in July 2009 and was mostly completed at the time of the earthquake, with only the grain conveyor systems still needing to be installed according to onsite facility personnel. Consequently, the

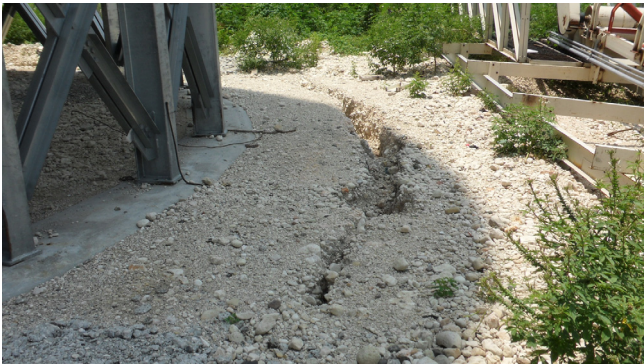
Figure 10. Crack in the soil around the base of the silos. This crack was likely made from uplift of the footing due to overturning moments induced by the earthquake shaking.

The grain silos appeared to have suffered little structural damage as a result of the earthquake shaking. However, surficial cracks in the soil around the base of the silos suggest that uplifting of shallow ring footing occurred due to seismically induced overturning moments. Preliminary calculations performed by the authors suggests that the silos would likely have overturned if they had been filled with grain at the time of the earthquake.

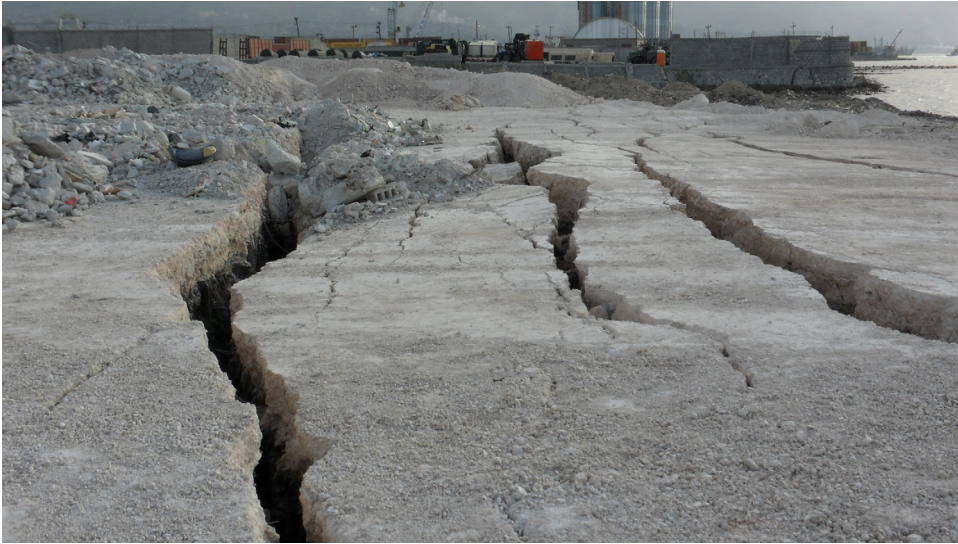
Figure 11. Lateral spreading in the storage yards in the northern part of the port facility.

Extensive lateral spreading also occurred in two storage yards located just north of the silos (Figure 11). Approximately 2.4 m of cumulative lateral displacement was measured at the northern storage yard. Similar to the silo area, these storage yards were constructed on garbage fill overlain by compacted gravel/cobbles (Rathje et al. 2010). Based on detailed inspection of the sidewalls of the lateral spreading cracks, the authors believe that lateral spreading was caused by liquefaction of sand underlying the garbage fill, similar to the lateral spreads that occurred adjacent to the silos.

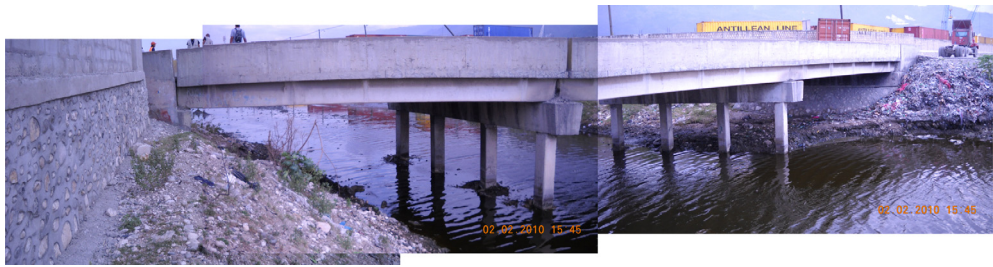
Figure 12. Profile of bridge connecting silo area to northernmost storage yards. Photograph taken looking eastward (i.e., the north end of the bridge is to the left).

A bridge connecting the silo area to the storage yards performed reasonably well during the earthquake, suffering only minor damage. The bridge is a three-span, bulb-T concrete beam bridge with each of the two intermediate piers and the abutments founded on four ~41-cmsquare precast concrete piles (Figure 12). As may be observed in Figure 13, minor crushing occurred between the northern and middle spans. Also, transverse movement (~10 cm) occurred between the southern and middle spans (see Figure 13). The south abutment fill soils showed negligible movements toward the drainage canal, while the north abutment fills slumped approximately 15 cm on the western side and approximately 5 cm on the eastern side. Several ground cracks also formed in the abutment fill cone near the waterline in the canal.

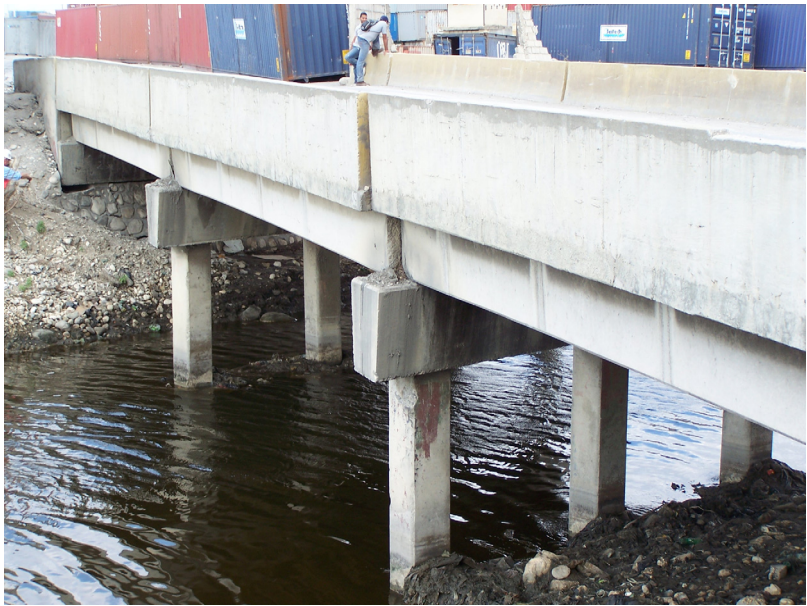
Figure 13. Minor crushing and lateral offset of middle and southern bridge spans for bridge connecting silo area to northernmost storage yards. Photograph taken looking northward.

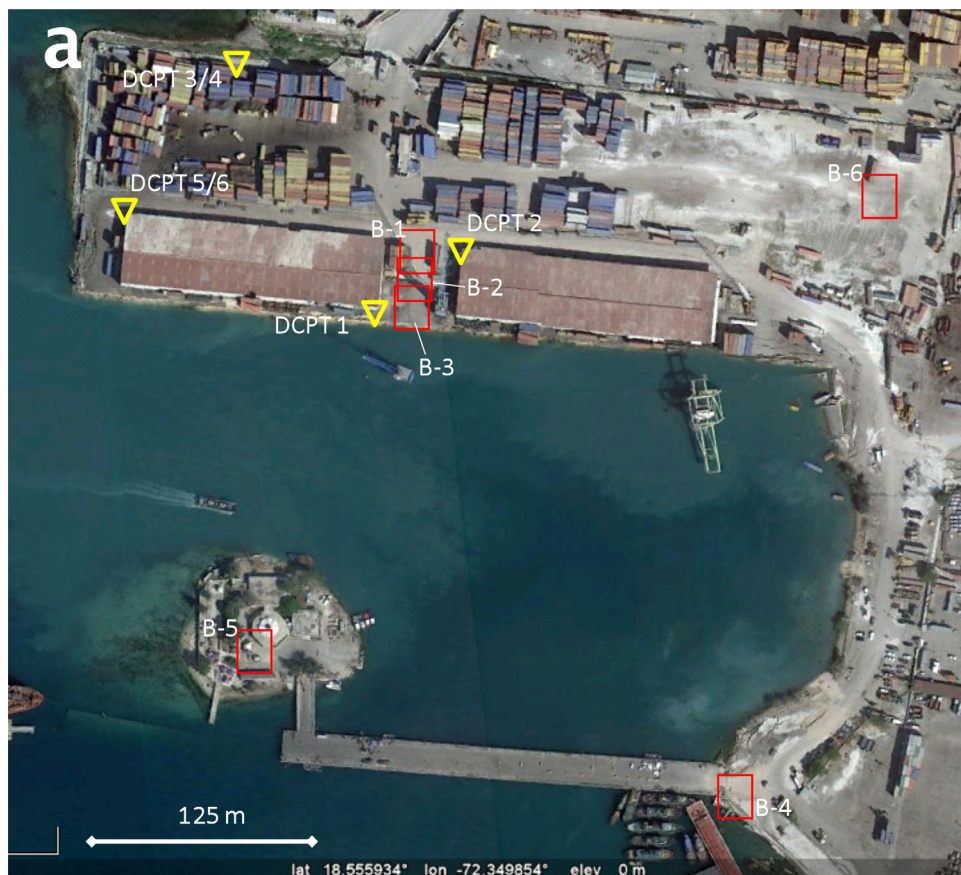
Figure 14. Location of borings with standard penetration tests and dynamic cone penetration tests.

Post-earthquake subsurface investigations at the port included borehole drilling and sampling, standard penetration tests (SPT), and dynamic cone penetration tests (DCPT). Figure 14 presents the locations of the tests performed at the port.

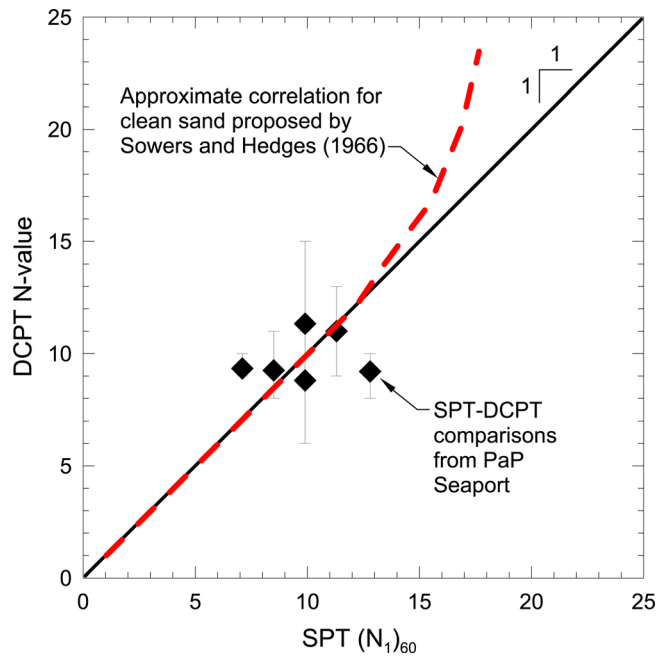
Figure 15. Comparison of SPT $(N_1)_{60}$ values and DCPT N-values measured at PaP Seaport.

Although a DCPT-based liquefaction evaluation procedure does not exist, a comparison of DCPT penetration resistance with SPT blow count suggests that a 1:1 correlation provides a reasonable match between the two data sets (Figure 15). This 1:1 correlation is consistent with the correlation for sands (with SPT blow count less than about 15) recommended by Sowers and Hedges (1966). As a result, we assumed a 1:1 correlation for all subsequent subsurface characterization and liquefaction analyses. Finally, the DCPT has been used on several other recent post-earthquake investigations (e.g., 2010, M_w 8.8 Maule, Chile, earthquake and the 2010, M_w 7.1 Darfield, New Zealand, earthquake) to evaluate deposits that liquefied.

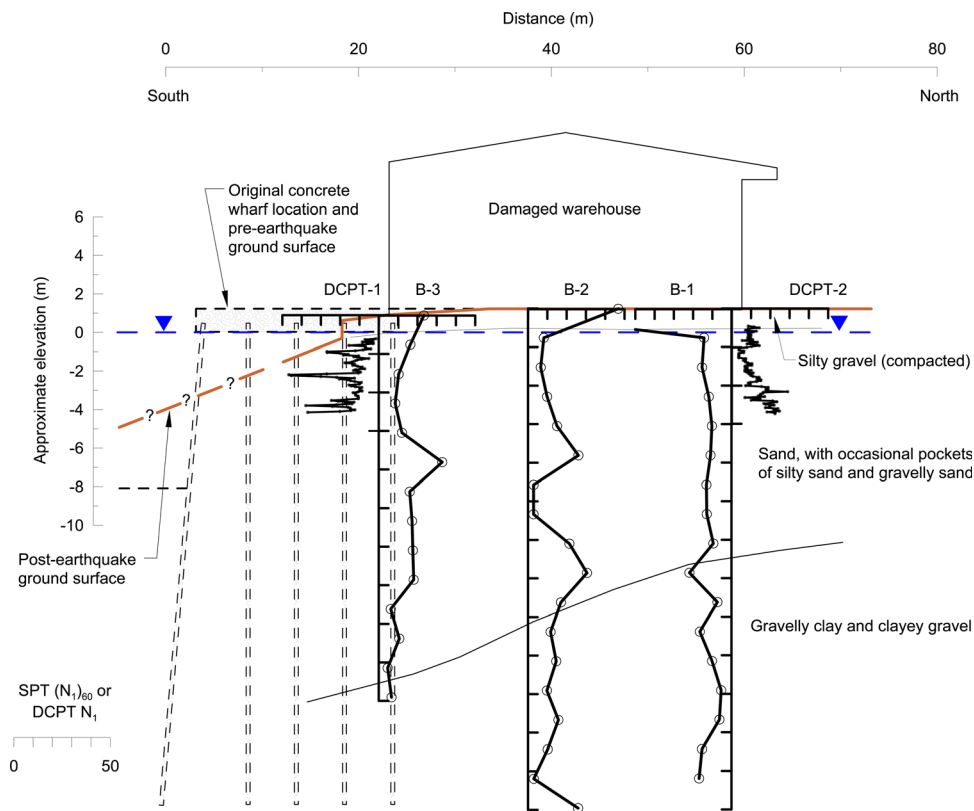
Figure 16. Geotechnical profile of south edge of North Wharf.

Using the hand-auger logs, boring logs, and subsurface samples retrieved from the site, the authors developed subsurface profiles at the south end of the north wharf. The profile is presented in Figure 16. Figure 17 presents additional DCPT and SPT data.

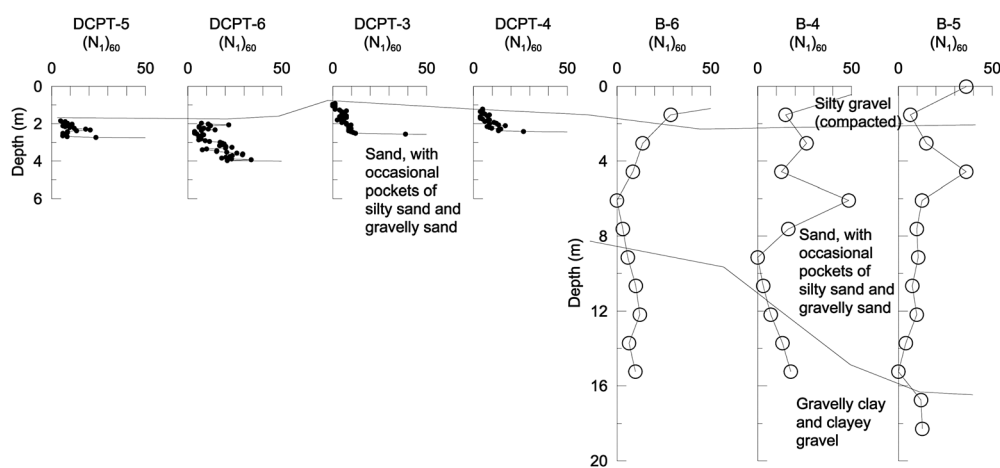
Figure 17. Additional penetration test results from North Wharf and South Pier areas.

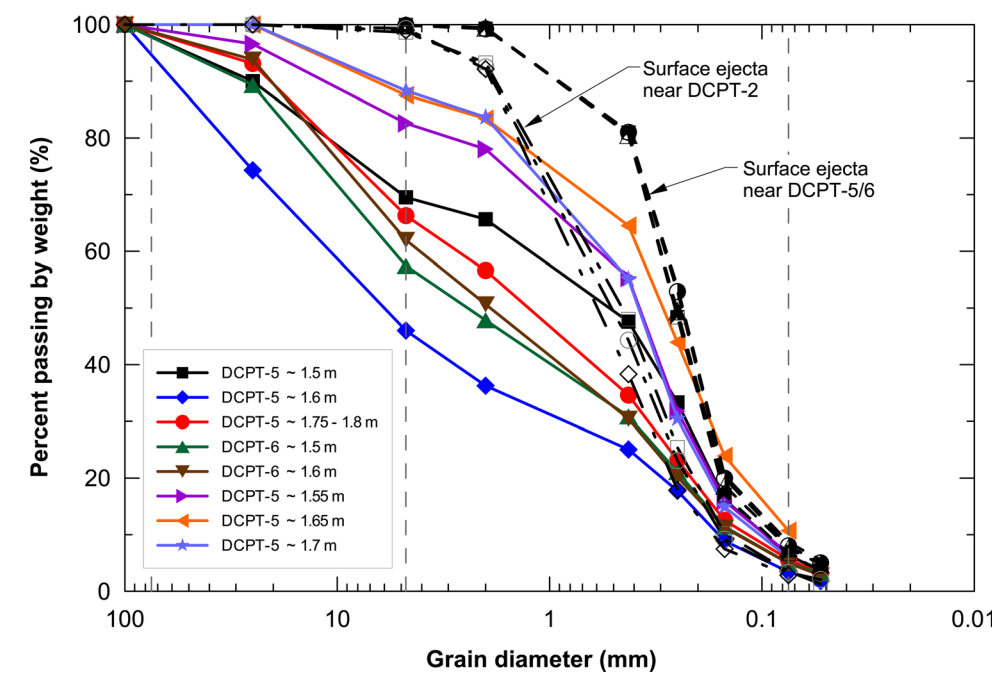
Figure 18. Grain size distributions for samples obtained from hand augered borehole adjacent to soundings DCPT-5 and DCPT-6, and grain size distributions for sand boil ejecta samples obtained near DCPT-5/6 and DCPT-2.

Figure 18 presents grain size distributions of sands retrieved from hand-augered boreholes for soundings DCPT-5 and 6, and illustrate the well-graded nature of the fill sands at the site. The coarser fraction of the samples consists of subrounded to subangular sands and gravels, with large fragments of coral and shells causing the grain size distribution to

appear broader than the calcareous matrix sand. This is also evidenced by the grain size distributions of the ejecta retrieved from the surface sand boils observed near DCPT-2 and DCPT-5/6, which show almost no gravel-sized particles. Both the *in situ* samples and surface ejecta samples were relatively clean sands, with most samples exhibiting a fines content (FC) less than 5%, and all samples exhibiting $FC < 8\%$. The fines are calcareous and generally nonplastic when considered as a mass, although the fines fraction contained a small amount of low plasticity material based on the moderate dry strength of a thin crust that formed on the ejecta.

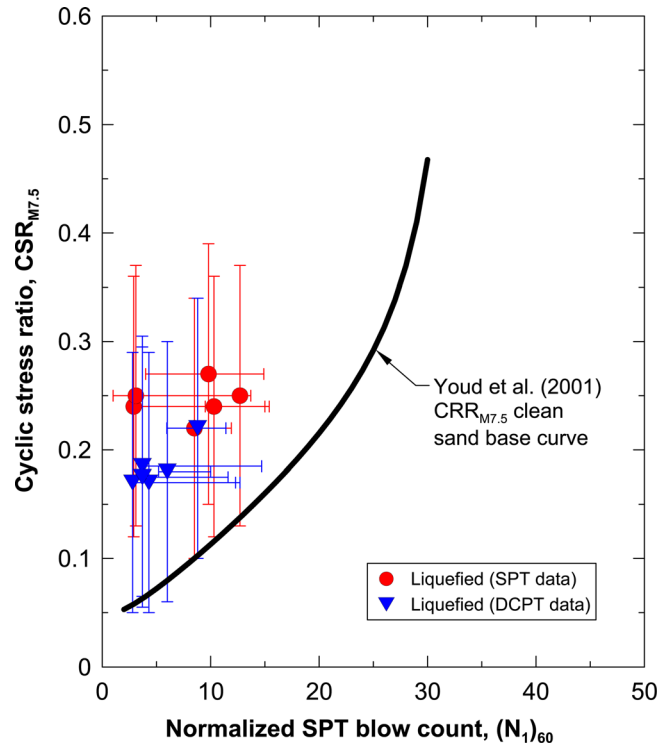
Figure 19. Level ground liquefaction analysis for SPT and DCPT results, to include error bars. Note that CRR base curve was derived from mathematical expression in [Youd et al. \(2001\)](#).

Figure 19 and Table 2 present the liquefaction analysis using SPT borings B-1 through B-6, as well as DCPT soundings 1 through 6. Although neither the SPT N-values (performed through hollow-stem augers) nor DCPT N-values are preferred for evaluating

liquefaction potential, these computations clearly illustrate that the seaport fills are highly susceptible to liquefaction. Additionally, the SPT N-values suggest that the sands may be very loose to depths ranging from 5 to 19 m, consistent with the severe liquefaction effects observed at the surface.
