# **THERMAL INTEGRITY PROFILING: A RECENT TECHNOLOGICAL ADVANCEMENT IN INTEGRITY EVALUATION OF CONCRETE PILES.**

**Evgenia-Anna Sellountou\*, Ph.D., and Camilo Alvarez\*\*, P.E.**

\* *Pile Dynamics Inc., 30725 Aurora Rd., Cleveland, Ohio, 44139, <ASelloutou@pile.com>*

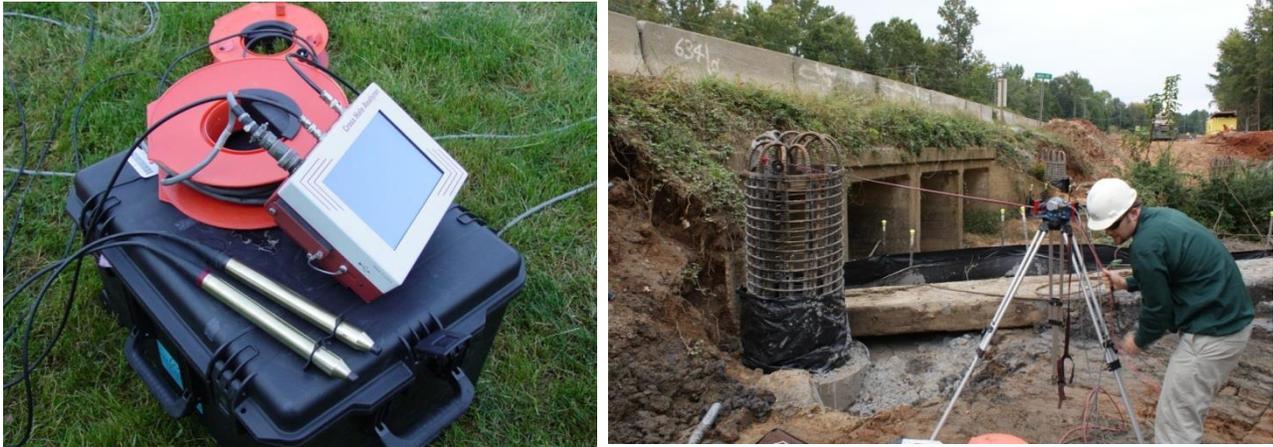
**Figure 1: CSL Testing equipment (left), a GRL engineer performing CSL testing (right)**

One of the most commonly used NDT testing methods for the integrity evaluation of deep foundations is the Cross-hole Sonic Logging (CSL). The test configuration requires pre-installed access PVC or steel tubes attached to the reinforcement cage prior to concrete casting. Typically one tube per 300 mm of diameter with a minimum of three tubes (preferably four) are cast in the pile. The CSL principle is to measure the travel time and signal strength of ultrasonic waves travelled between two probes through concrete. The test equipment and set up used are shown in **Figure 1**.

The two probes (one transmitter and one receiver) are inserted into parallel access tubes filled with water and lowered down the pile. Both probes are pulled slowly up the pile (**Figure 1, right**) while the transmitter emits ultrasonic waves that travel through the concrete and are received by the receiver probe. Measurements of First Arrival Time (FAT) and signal strength (“energy”) are taken during the pulling of the probes. Once the probes reach the top of the tubes they are moved to other access tubes within the same shaft, until all possible path combinations have been tested. Cross-hole Sonic Logging is performed in the United States in accordance with ASTM D6760.

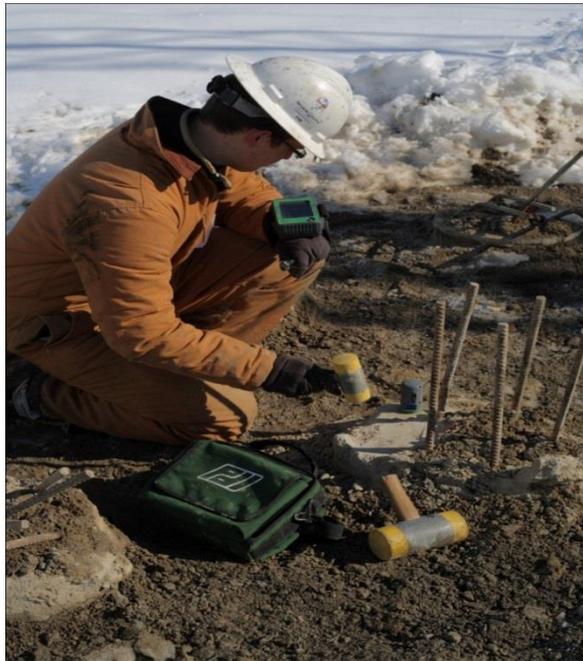
**Figure 4: Low strain integrity test equipment and configuration (PIT-X Unit)**

Low Strain Integrity Testing or Pulse Echo Test is commonly used for integrity evaluation of deep foundation elements. In the United States this test is performed in accordance with ASTM D5882. It is a quick, easy, and inexpensive test. Unlike CSL test described above, low strain integrity testing doesn't require pre-planning (pre-installed access tubes) in order to be performed. The test configuration consists of i) a hand held hammer (to apply a light tap to the pile top); ii) an accelerometer attached at the pile top to measure the stress wave induced by the hammer; and iii) a processing unit, which displays and stores the received signals. **Figure 4** shows the performance of a low strain integrity test using a small and convenient processing unit attached to the wrist of the engineer.

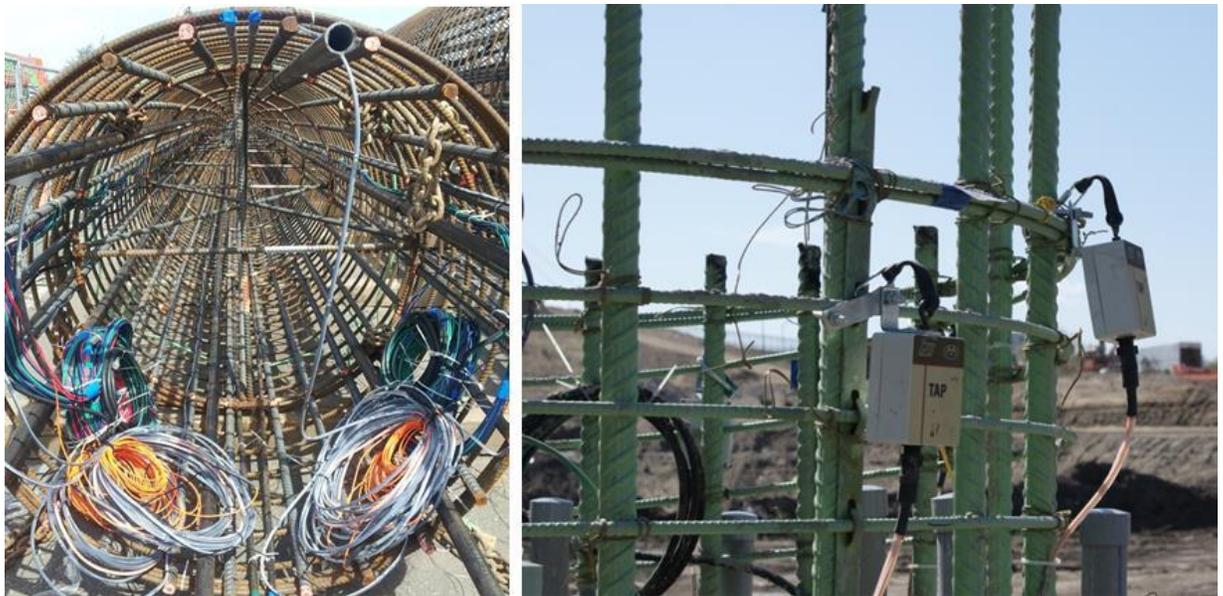
Figure 9: Thermal Wire cables installed in the cage (left), TAP data collector units connected in the cables (right)

Temperature measurements can be made either with infrared probes inserted into dewatered CSL-like inspection tubes (as shown in **Figure 8**), or with Thermal Wire<sup>®</sup> brand cables attached to the reinforcing cage prior to casting the shaft (**Figure 9**) and continuous temperature monitoring can be made in preselected time intervals.

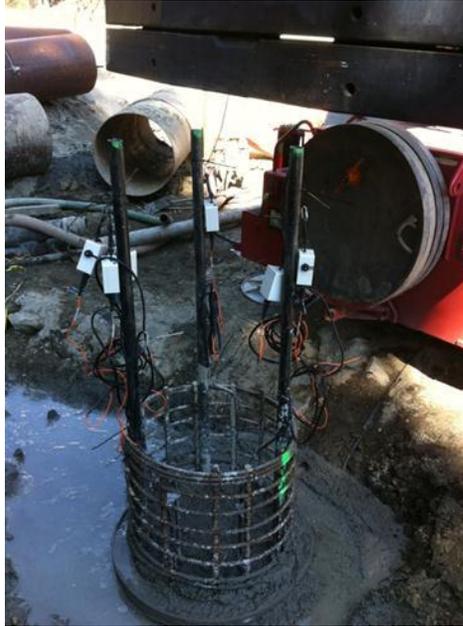
**Figure 10: Test Shaft A - Halstead Meadows Bridge - Sequoia National Park, California**

Shaft A was drilled under polymer slurry with a nominal diameter of 36 inches (914.4mm) and a measured length of about 48 ft (14.6m). A full length 30-inch (762mm) diameter reinforcement cage was used along with a 30-ft (9.1m) long steel casing in the upper pile portion to assure soil stability. Installation records showed 15 cubic yards (11.5m<sup>3</sup>) of concrete were used for Shaft A. Four thermal wires and three steel CSL access

tubes were installed. **Figure 10** shows the installed thermal wires coming out of the pile top and connected to the TAP units (thermal acquisition ports) as well as the steel CSL tubes extruding from the top of the pile.

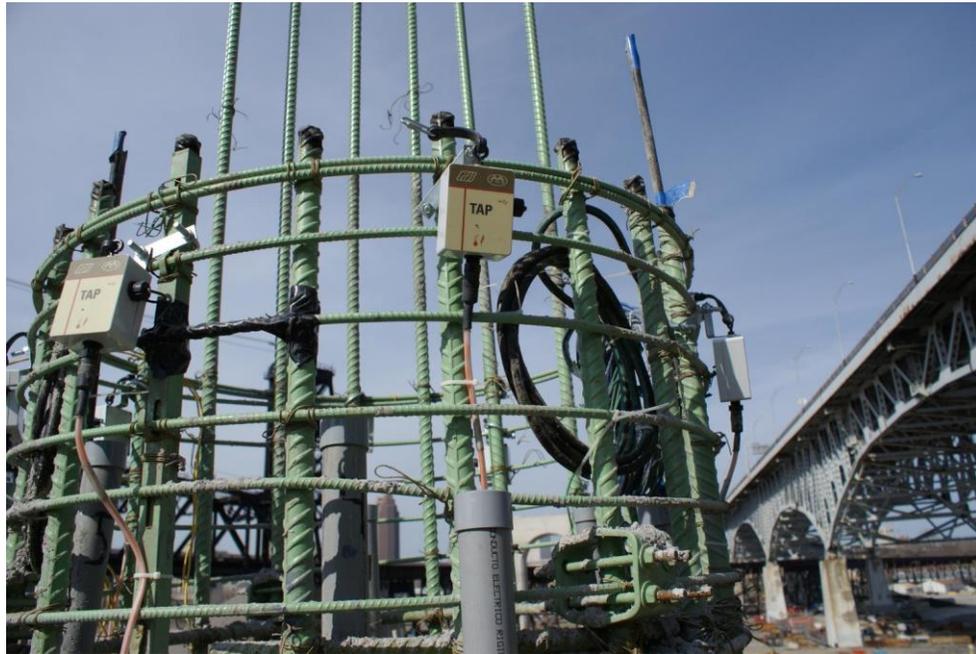
**Figure 14: Innerbelt Test Shaft, Cleveland, Ohio**

Thermal wire cables were delivered in 100-foot (30.5m) sections, and spliced with a quick connect waterproof connector at the splice location. Six of the wires extended from the top of the shaft to the top of the Osterberg Cell. The remaining two wires extended past the cell to the bottom of the rebar cage. A picture of the TAP data collection units at the top part of the instrumented cage installed in the shaft is shown in **Figure 14**.
