A large aquifer in Canton, OH caused difficulties in foundation installation for new ramp and mainline bridge structures on I-77. The design called for drilled shafts to be installed, but an early demonstration shaft indicated the aquifer created conditions that prevented the use of drilled shafts at one pier location, as the design called for the shafts to penetrate the aquifer. The awarded contractor, [The Beaver Excavating Company](#), evaluated the situation and made the necessary changes to the installation plan. Initially, GRL Engineers were contracted to evaluate the shaft bearing soil using the [Shaft Quantitative Inspection Device \(SQUID\)](#), evaluate shaft integrity using [Thermal Integrity Profiling \(TIP\)](#), and perform Dynamic Load Testing using an APPLE drop hammer to evaluate shaft capacity.

Due to the difficulties of installing deep drilled shafts, ODOT broached uncharted territory and the design for the pier in question was changed to continuous flight auger (CFA) piles. Static Load Testing, Dynamic Load Testing with CAPWAP® Data Analyses, and TIP were implemented on the CFA piles.

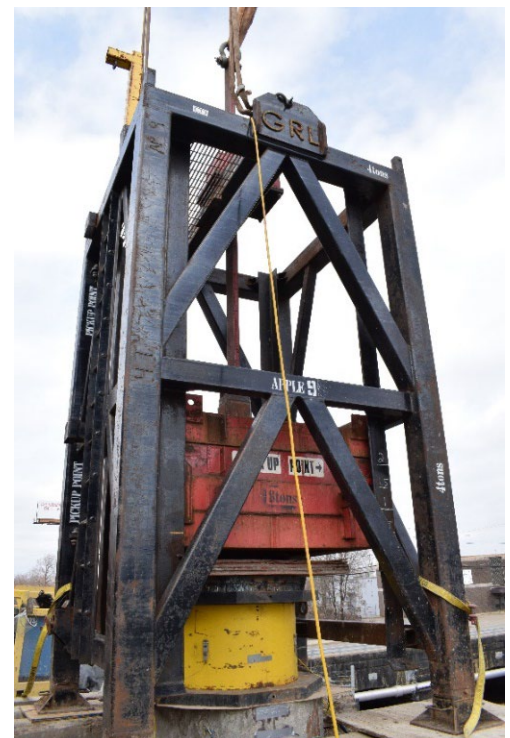
quickly and at a fraction of the cost of performing large Static Load Tests. Data acquired from the dynamic tests were then analyzed in the CAPWAP software program to further evaluate static capacity including the soil resistance distribution along the shaft and at the toe.

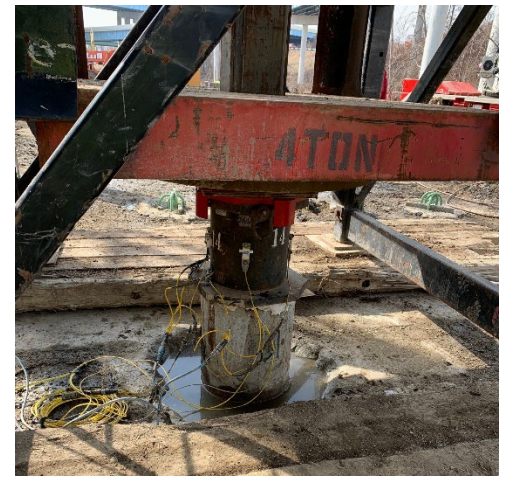
Figure 1: APPLE Load Test Drop Weight System with Top-Loading Transducer – Phase 1

[Dynamic Load Testing](#) was performed on 3 shafts using an APPLE drop weight system (**Figure 1**). The shafts were impacted with a load testing device utilizing a 32-kip ram weight and variable drop height. Drop heights used during testing ranged from 1.0 foot to 5.5 feet. Each dynamic load test was completed in a single day and allowed the designers and owner to confirm the shaft design and load carrying ability.

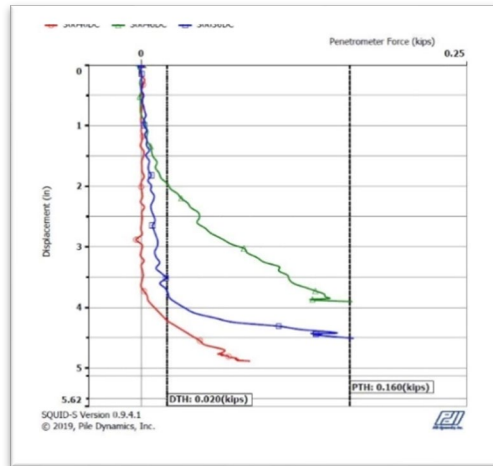
Figure 3: SQUID test results indicating dense soils at the shaft toe – Phase 1

In phase 1, the SQUID test results indicated variable conditions at the shaft toe, some areas where the shafts terminated above the aquifer indicated relatively dense soils (**Figure 3**), while other locations, apparently within the aquifer, indicated almost no strength (**Figure 4**), as if the soil was suspended. TIP results illustrated the contractor had installed quality shafts (**Figures 5 & 6**). Dynamic Load Testing using the APPLE drop weight system allowed for multiple load tests to be conducted

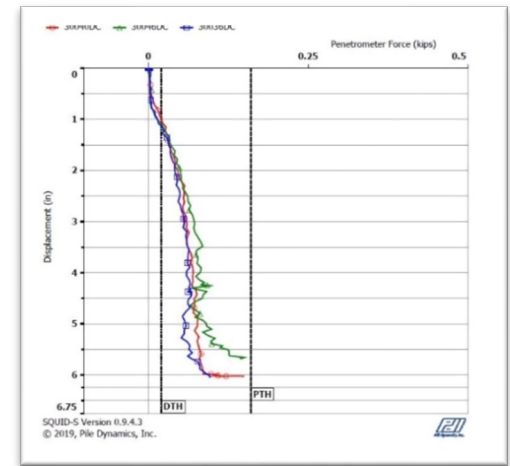
Figure 4: SQUID test results indicating very little soil strength at the shaft toe – Phase 1

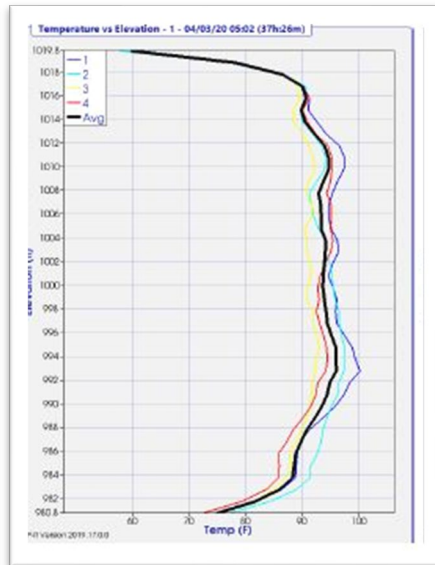
Figure 6: Thermal Integrity Profiling results, temperature vs elevation – Phase 1

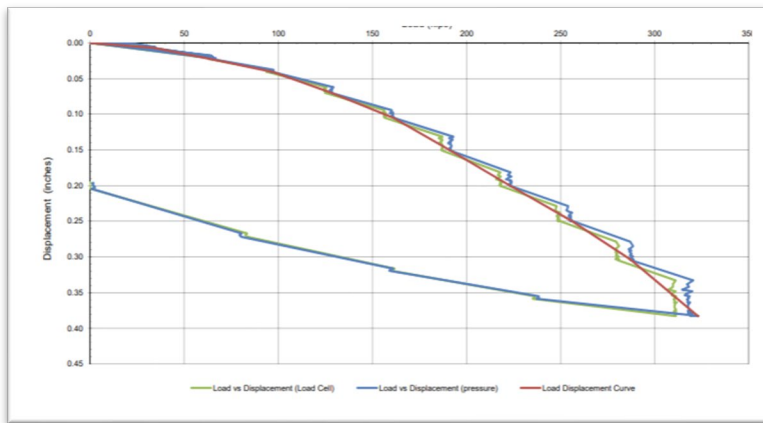
Figure 7: Data results from Static Load Test on ACIP Pile – Phase 3

Phases 3 and 4 of construction included the first CFA piles used to support a bridge structure in ODOT history. GRL Engineers performed the first Dynamic Load Tests on CFA piles for ODOT (Figure 7). [Static Load Tests](#) and CAPWAP Analysis were implemented to compare data from the Dynamic and Static Load Tests. The maximum mobilized capacities for the tested piles were well above the required nominal pile resistance (Figure 8).

During Static Load Testing, the pile did not experience plunging failure, but the results were very comparable to the dynamic testing results. Ultimately, ODOT found the results from the Dynamic Load Test to be satisfactory and created a new supplemental specification for CFA piles. To learn more about GRL Engineers, visit [www.grlengineers.com](http://www.grlengineers.com) or email us at [info@grlengineers.com](mailto:info@grlengineers.com).

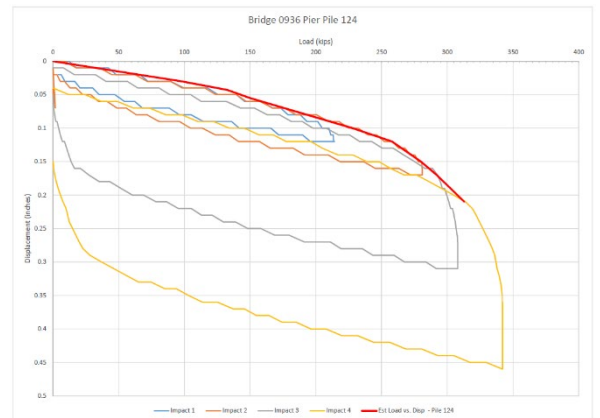
Figure 8: Data results from Dynamic Load Tests on ACIP Pile – Phase 4
