DRILLED SHAFT BASE QUALITY REDUCTIONS IDENTIFIED WITH THERMAL INTEGRITY PROFILING

Travis Coleman, P.E., GRL Engineers, Inc., Lincolnwood, IL, USA, tcoleman@grlengineers.com

Daniel Belardo, GRL Engineers, Inc., Solon, OH, USA, (440) 600-4115, dbelardo@grlengineers.com

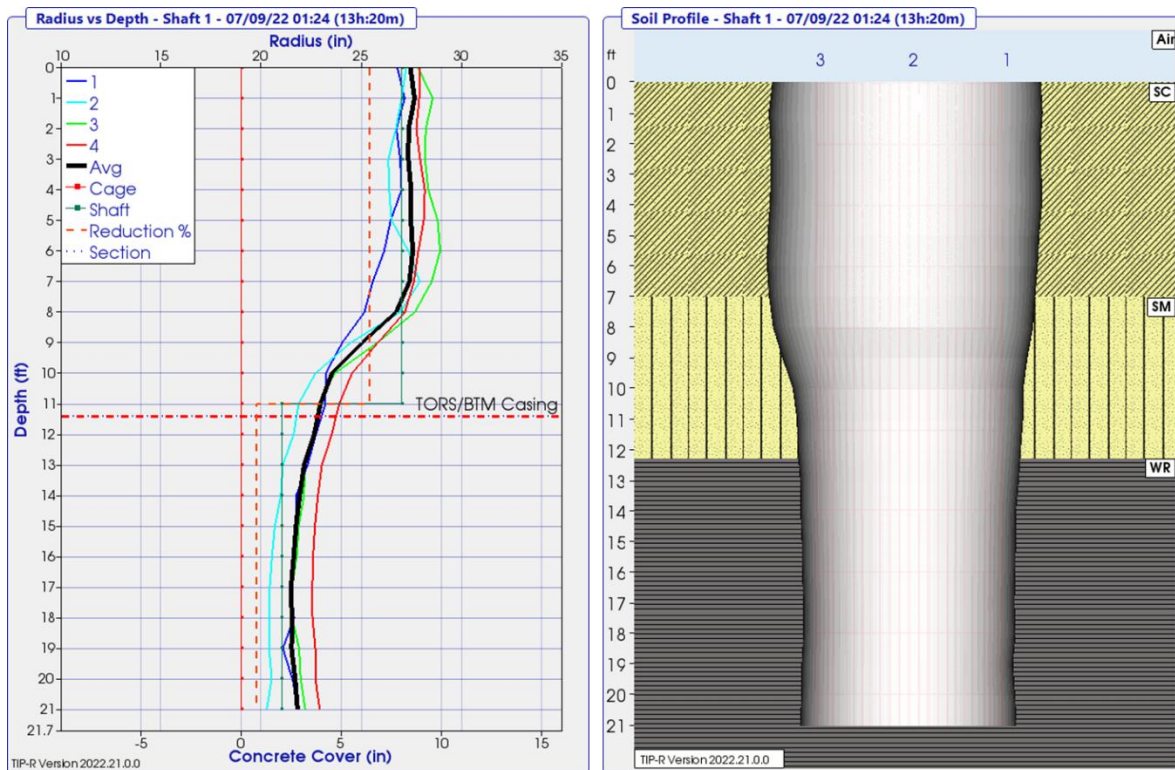
Results of the TIP analysis for Shaft 1 are presented in Figure 4. The left plot displays the Effective Radius vs. Depth, where the upper x-axis is the effective radius, and the bottom x-axis is estimated concrete cover. The reinforcing cage is represented by the vertical red dashed line. The green dashed line represents the nominal effective radii based on the reported casing and rock-socket diameters. The modeled effective average radius is consistent with the nominal shaft diameter and no anomalies are indicated. Note that after applying the BOS adjustment as detailed in Figure 3., the resulting shape is uniform near the bottom of the shaft. The right plot of Figure 4. presents a 3D representation of Shaft 1.

Fig. 4. Shaft 1: Effective Radius Graph (left) and 3D Presentation (right)

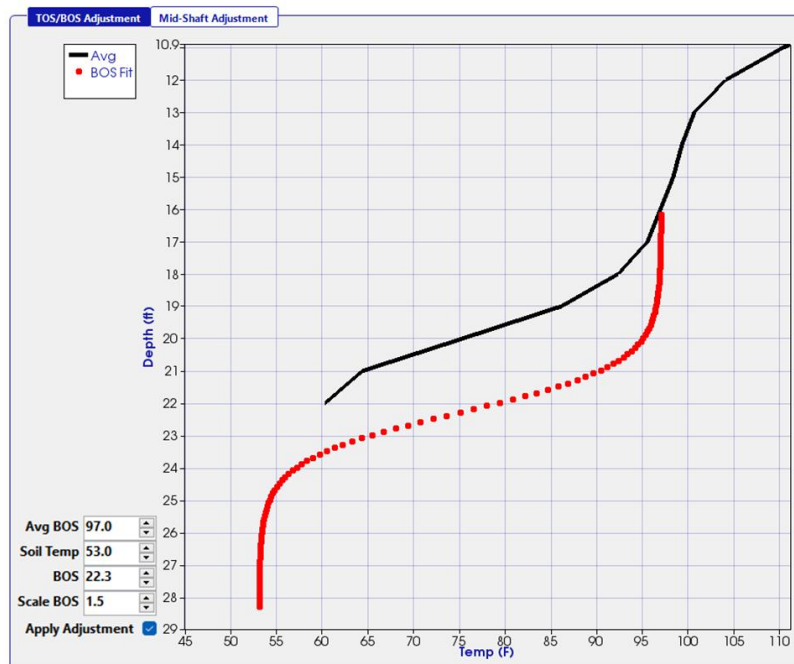
Using the same methodology for applying the BOS adjustments for Shaft 2, presented in Figure 6., as were used in Shaft 1, it is apparent that the expected heat loss does not match the collected data. The primary difference in the BOS adjustment inputs is the BOS value which represents the concreted shaft length. Shaft 2 was installed to a depth of 22.3 feet (6.8m). After applying the BOS adjustment, the measured average temperature is well above the expected heat loss curve. In this case, even the most aggressive adjustment, with the curve at the bottom of the shaft, cannot significantly improve the reduction near the shaft bottom. An early roll-off is an indication of a potential soft toe condition.

Fig. 6. Shaft 2: Bottom Roll-Off Adjustment

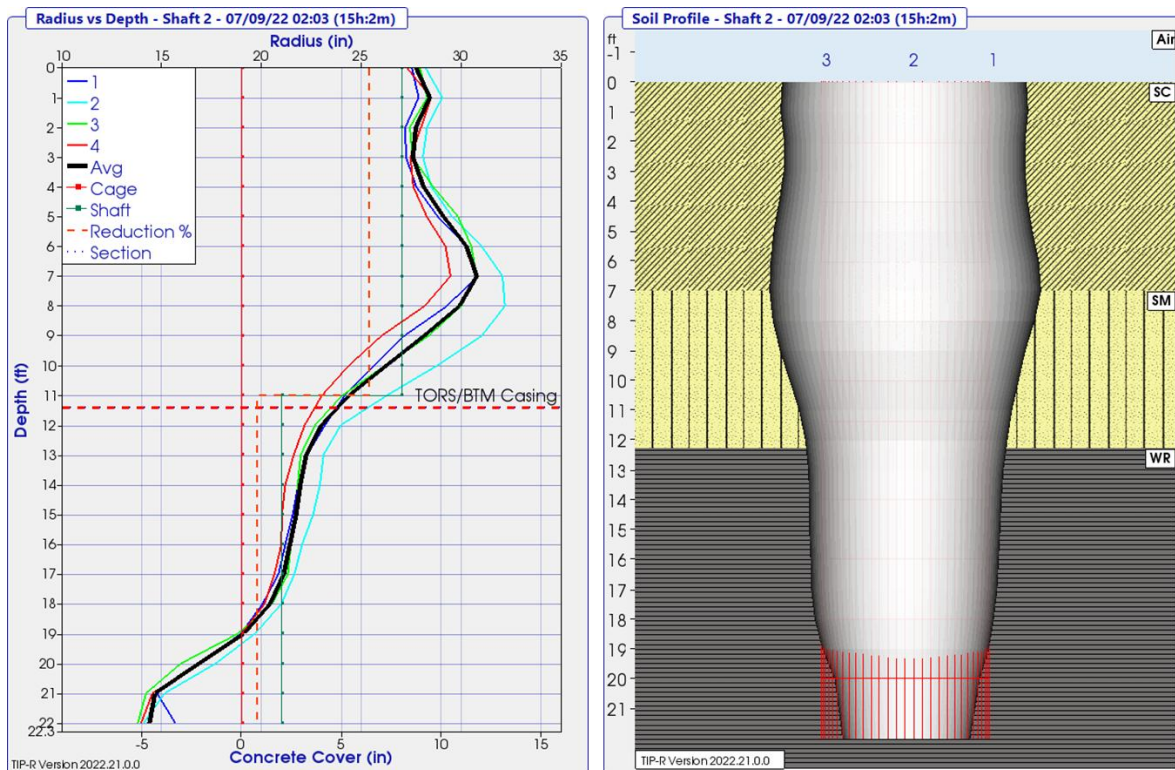
Figure 7 presents the results of the TIP analysis for Shaft 2. The modeled effective average radius is consistent with the nominal shaft diameter to a depth of 18-feet (5.49m). Below that depth, the effective radius reduces significantly, and is modeled as less than the cage radius for the lower 3-feet (.91m) of the

shaft. Since all cables indicate a reduction, this may be an indication of a cross-sectional quality reduction. The 3D representation of Shaft 2 shows the exposed cage near the bottom of the shaft.

Fig. 7. Shaft 2: Effective Radius Graph (left) and 3D Presentation (right)

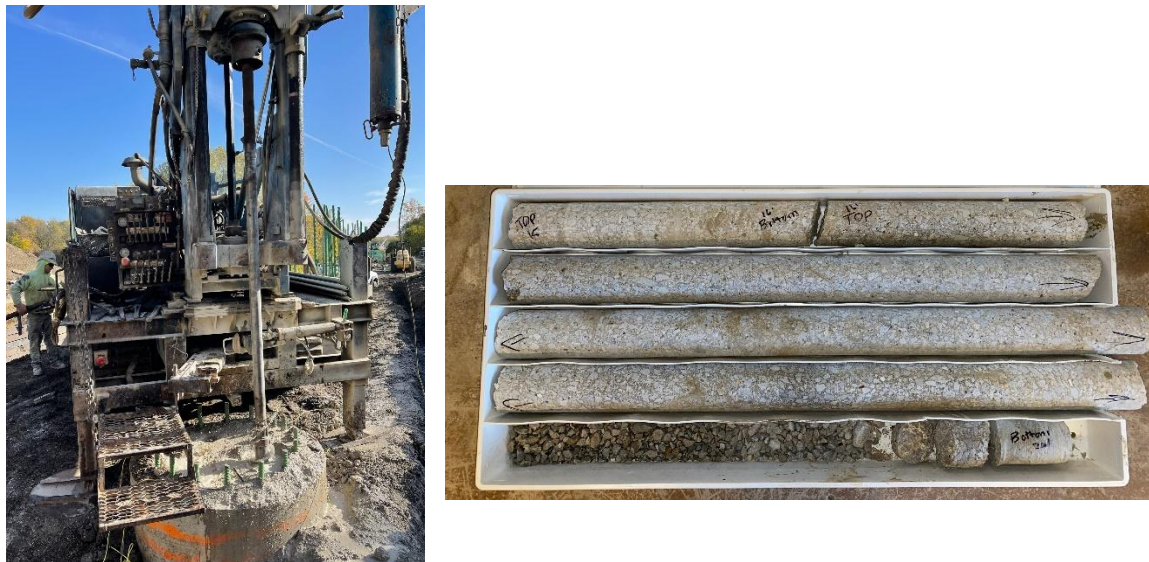
Based upon the results of TIP testing, further investigation was recommended. Exploratory coring of Shaft 2 was performed. Figure 9 shows the core rig positioned to drill approximately 6-inches (15.2cm) inside the rebar cage at the shaft top and the extracted core results at the bottom of the shaft. The core shows limited recovery and segregated concrete over the lower 2-feet (0.61m). The soft toe condition was verified, which initiated remediation efforts.

Fig. 9. Shaft 2 Coring Operation (left) and Retrieved Cores (right)

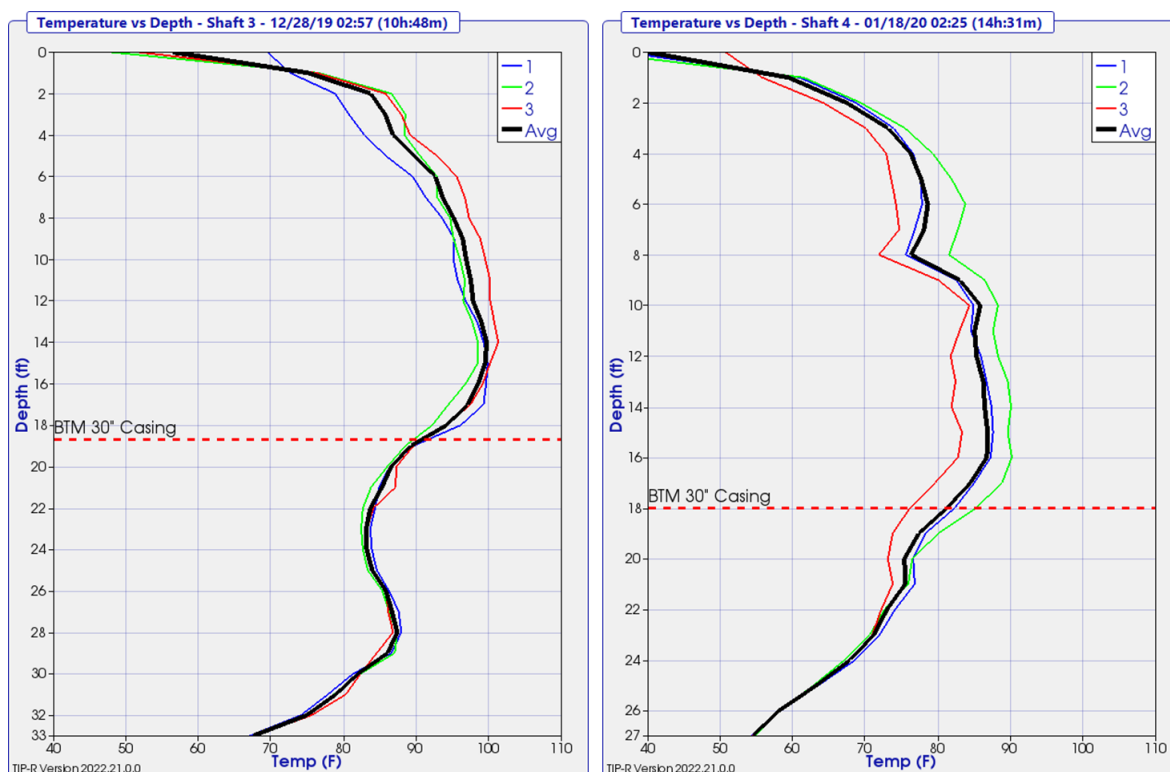
Figure 10 shows the Temperatures vs. Depth for Shaft 3, with a profile as expected, and Shaft 4, with indications of a soft bottom. Similar to Example Project 1, the bottom of shaft temperatures for Shaft 4 contain an inflection point in the bottom roll-off and the temperature roll-off begins well above the expected values.

Fig. 10. Shaft 3 and 4 Temperatures versus Depth Graphs

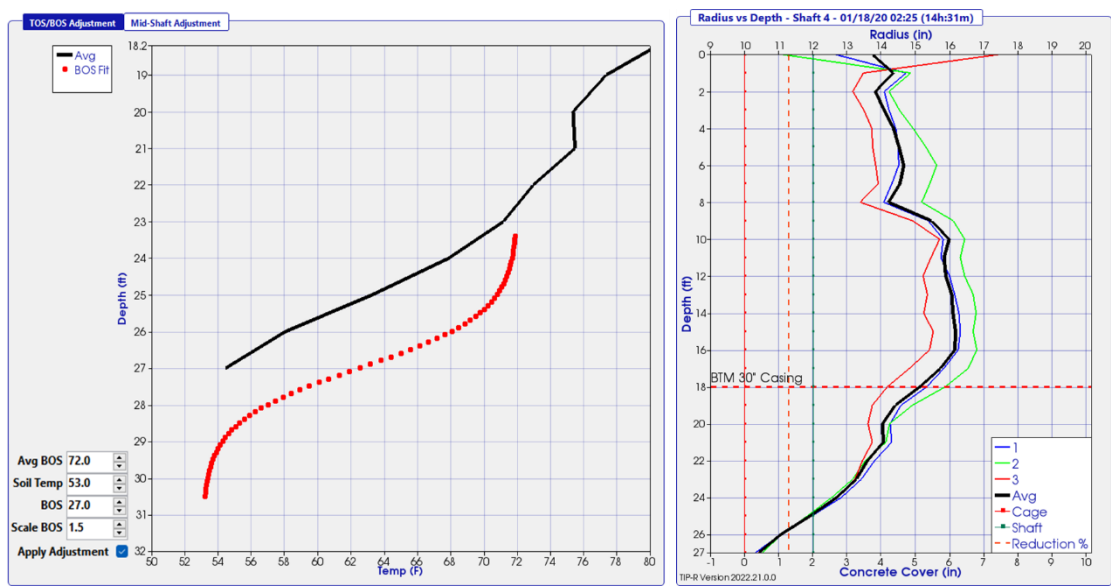
The effective radius of Shaft 2 is presented in Figure 11 (right). When modeled based on the theoretical volume, the TIP model indicates an effective radius greater than the cage radius at the shaft bottom. However, the sharp linear reduction in effective radius is cause for further investigation. Since all cables

indicate a drop in temperature, this may be an indication of a cross-sectional reduction in quality near the shaft base.

Fig. 11. Shaft 4: Bottom Roll-Off Adjustment (left) and Effective Radius vs. Depth (right)

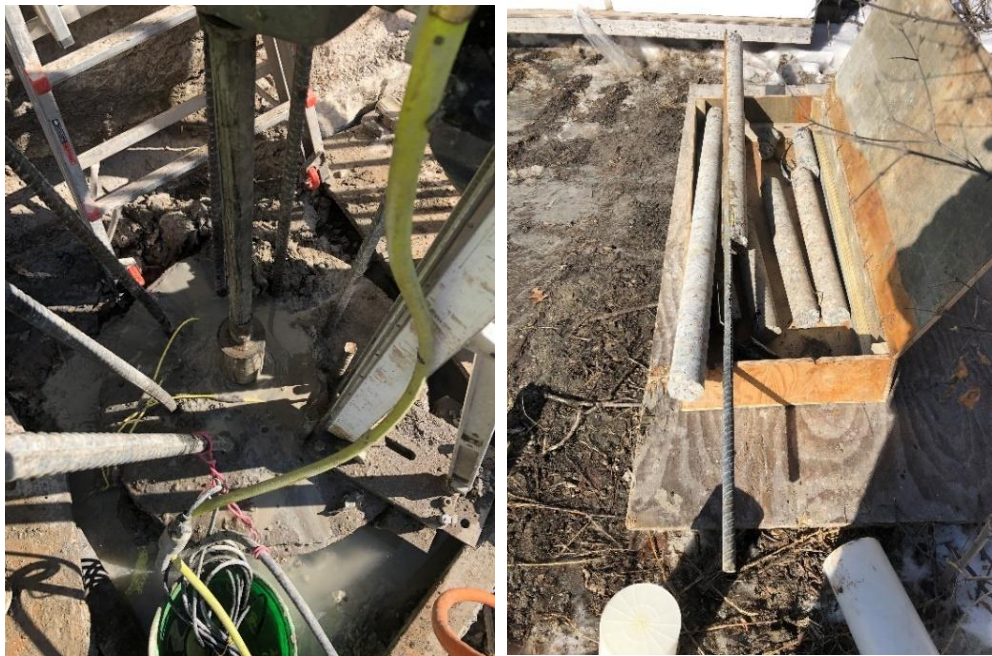
Based on both the effective radius model and the temperature generated at the shaft bottom, further investigation was recommended. Coring operations and cores are shown in Figure 13. The attached section of rebar indicates the length of core without retrieval.

Fig. 13. Shaft 4 Coring Operation (left) and Retrieved Cores (right)
