Central 70

Challenge:

The Central 70 Project is a \$1.2 billion endeavor to improve the widely used highway in Colorado. The project was started in 2018 to update the aged highway with 10 miles of reconstructed roads, add a new express lane in each direction, update the viaduct, lower the interstate, and construct a 4-acre park over part of the lowered interstate. The project's contractor, Kiewit contracted GRL Engineers in 2020 to assess drilled caisson integrity with non-destructive testing methods for the BNSF Bridge Block and UPRR & Service Road over I-70 and bridges. The testing scope included a combination of [Thermal Integrity Profiling \(TIP\)](#), and [Crosshole Sonic Logging \(CSL\)](#). Over a duration of 2 years of testing, 50 plus drilled caissons have been tested by GRL Engineers.

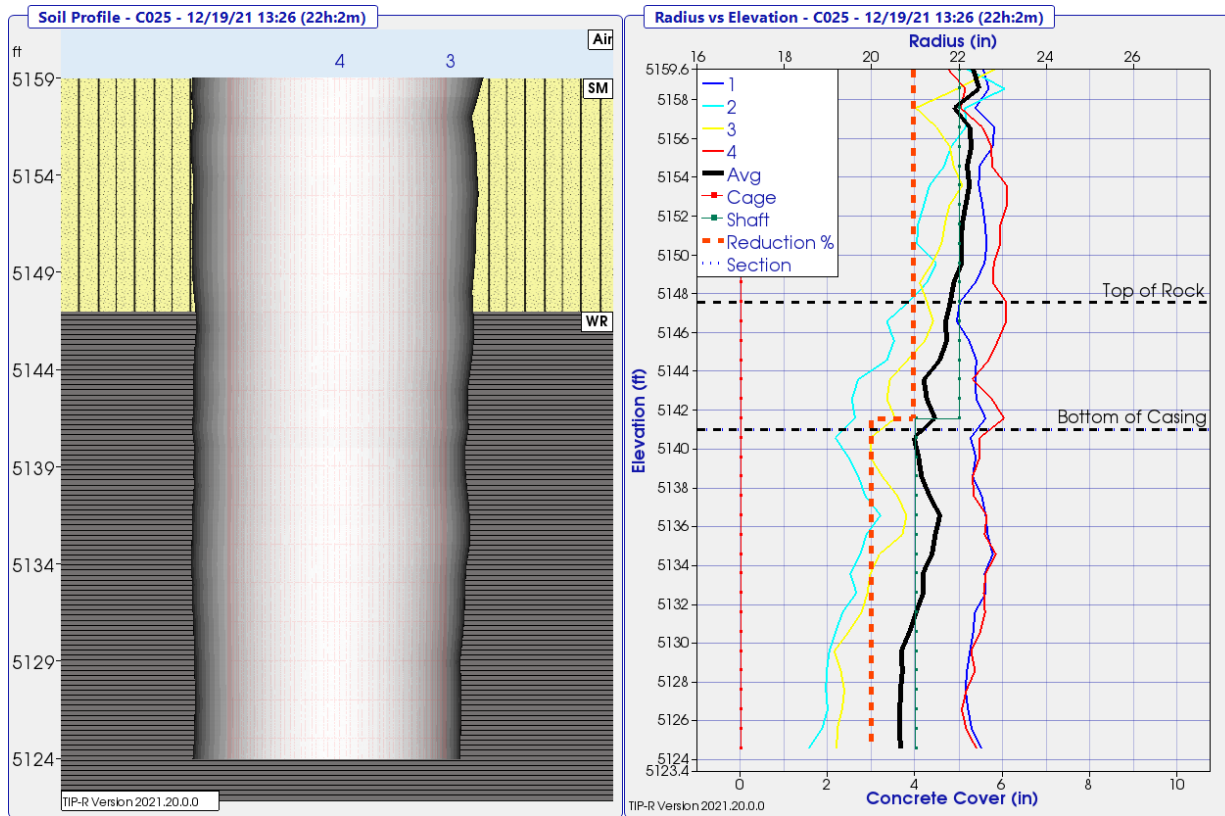
Figure 1. Sample Thermal Integrity Profiling Results

During concrete curing, hydrating cement generates heat, increasing the temperature in the caisson. The individual TAP units automatically record the measured temperature at each sensor location along the length of the wire, at 15-minute intervals, generating a profile of temperature versus depth at each time increment. **Figure 1** displays TIP test results from a 42-inch nominal diameter caisson. The crosshole sonic logging results, consisting of waterfall diagrams and corresponding plots of signal first arrival time and signal strength (energy), are provided in CSL testing results are represented in **Figure 2**. The combination of these testing methods provided a robust representation of the caisson integrity.

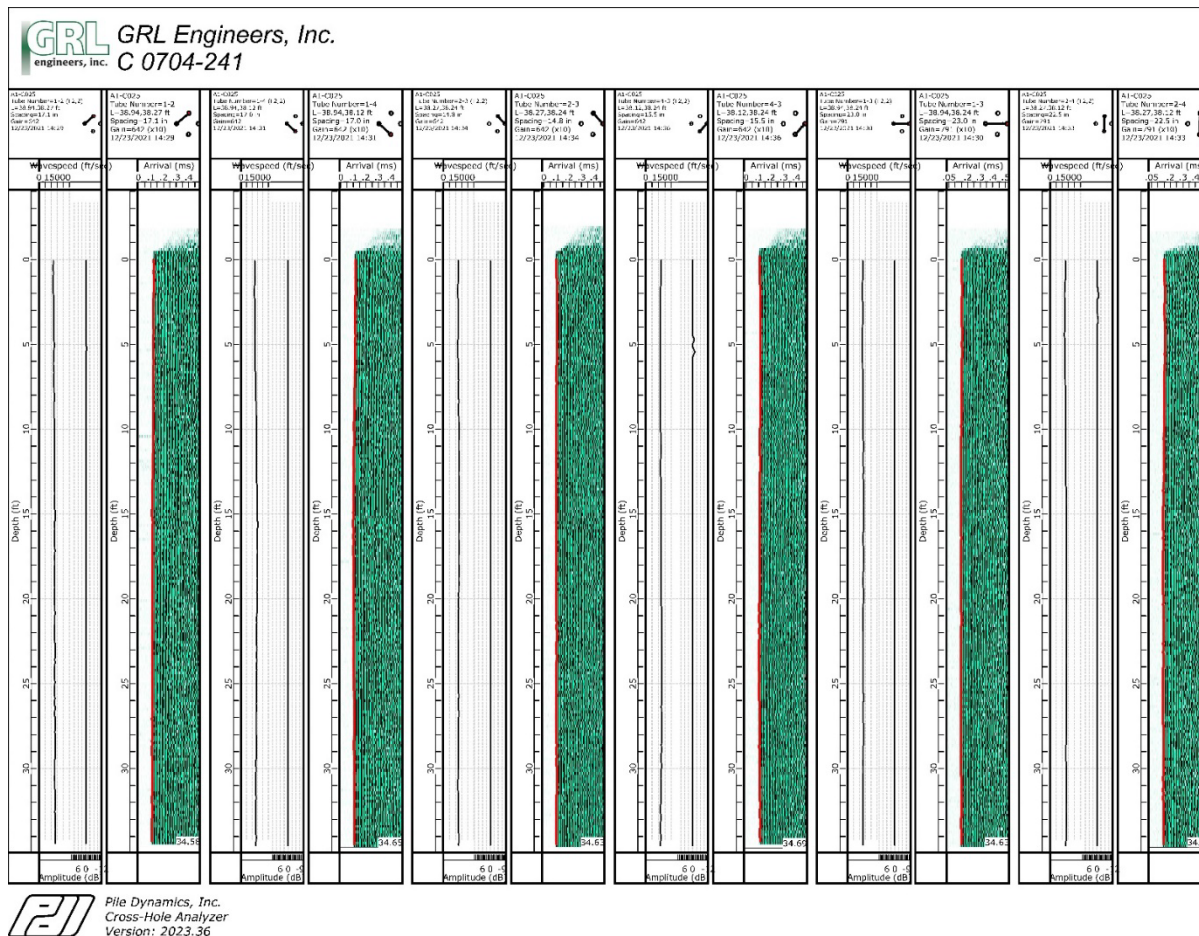
Figure 2. Sample Crosshole Sonic Logging Results

Working with Kiewit to meet UPRR, BNSF and CDOT specifications, GRL Engineers performed testing on the concrete integrity of many caissons. Thermal Wires were instrumented along the longitudinal bars of reinforcing cages to collect thermal data. The wires were attached TAP data loggers that collected and remotely transmitted stored data to the cloud in real-time. This allowed Kiewit and GRL to discuss potential anomalies in as little as 24 to 48 hours after concrete placement. CSL testing was performed on the caissons after a waiting period (i.e., typically after 48 to 72 hours). The CSL test method uses probes which were lowered into steel access tubes running the length of the caisson. The probes were pulled simultaneously while signals were collected between transmitter and receiver. This data was analyzed to determine the concrete consistency between the tubes.
