West Virginia Shaft Bottom Cleanliness Specifications

Project Details

Client: West Virginia DOH

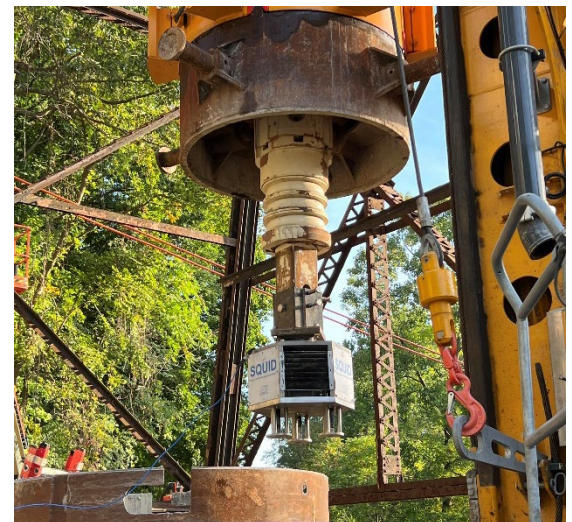
In **Figure 1**, penetrometer force-displacement results are shown from a test for a drilled shaft bearing in shale bedrock (Hannigan et al. 2021). The shaft excavation had been left open and filled with drilling fluid for four days prior to the testing. Due to degradation of bedrock over time, over 123.5 mm (4.86 in) of displacement occurred crossing the specification limits of 1.25” of thickness. The shaft was subsequently drilled 0.3 m (11.8 in) deeper, followed by cleaning with an airlift, and

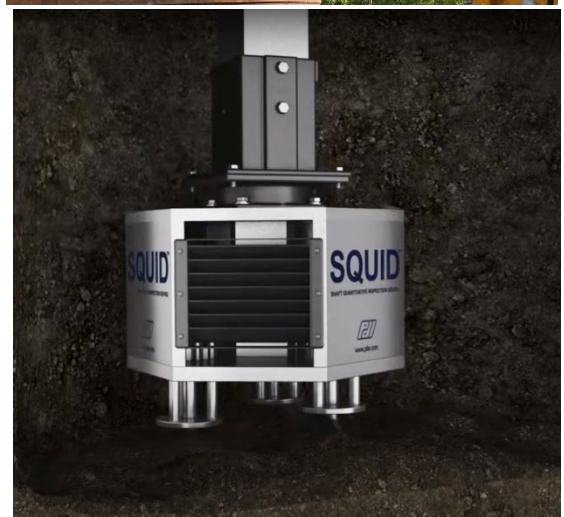
immediate SQUID retesting. The re-test results, shown in **Figure 2**, indicated from 11.5 m (0.45 in) to 19.9 mm (0.78 in) of debris, which was below the project specification limits.

Figure 2. SQUID results from shale bedrock redrilled and cleaned by air lifting.

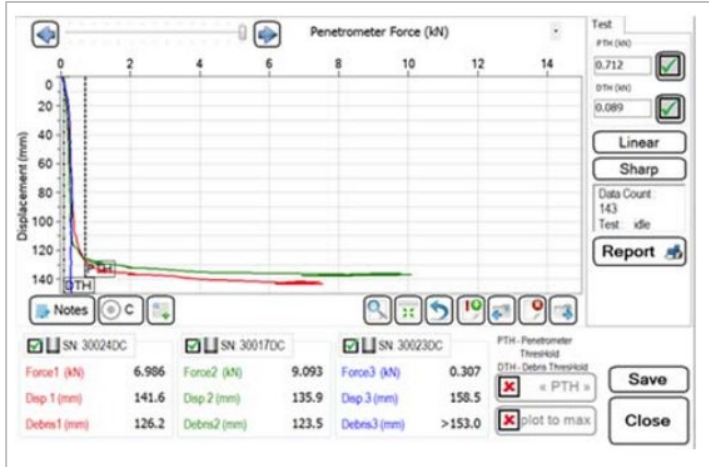
Figure 1. SQUID results from shale bedrock exposed to drilling fluid for four days.
