INTEGRITY ASSESSMENT OF A DIAPHRAGM WALL USING THERMAL INTEGRITY PROFILING

Sumanth H C, Sarathy Geotech and Engineering Services Pvt Ltd, Bengaluru, Karnataka, India, +91 9844875450, sumanth@sarathygeotech.com

DIAPHRAGM WALL

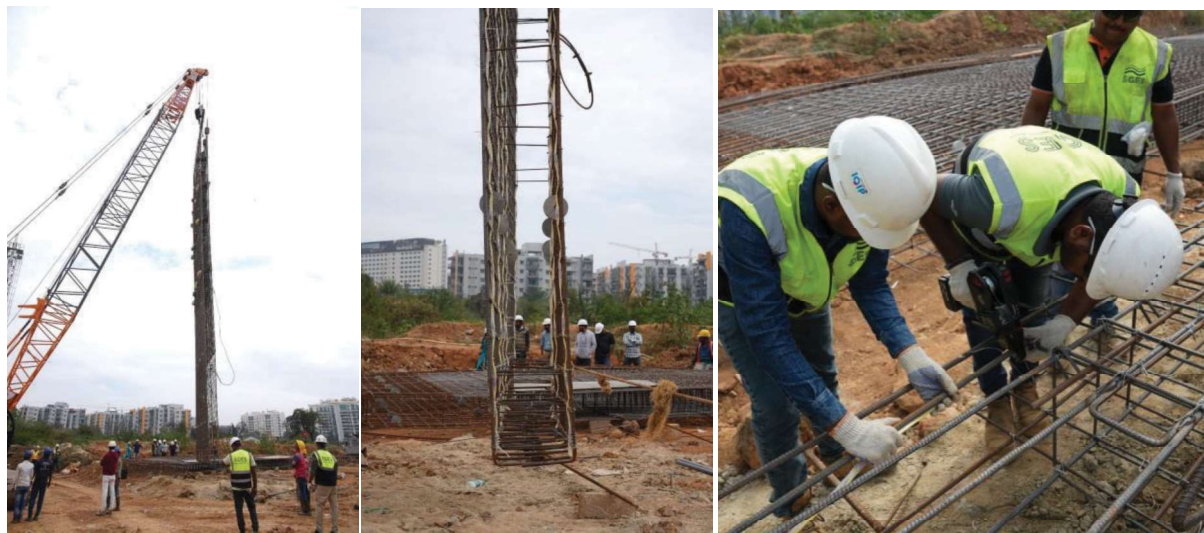
Fig.3 Thermal wires rigged up on panel-63

In this specific case, 10 thermal wire cables were installed along the entire length of the reinforcement cage. 5 wires per side uses the 1 m maximum spacing from ASTM D7949. Figure 3 presents the reinforcement cage with thermal wires during the process of lifting the cage and lowering it into the excavation. Binding wires were used to secure the thermal wires at reinforcement joint locations and cable ties were used along the length of the wires to secure the wires to the reinforcement.

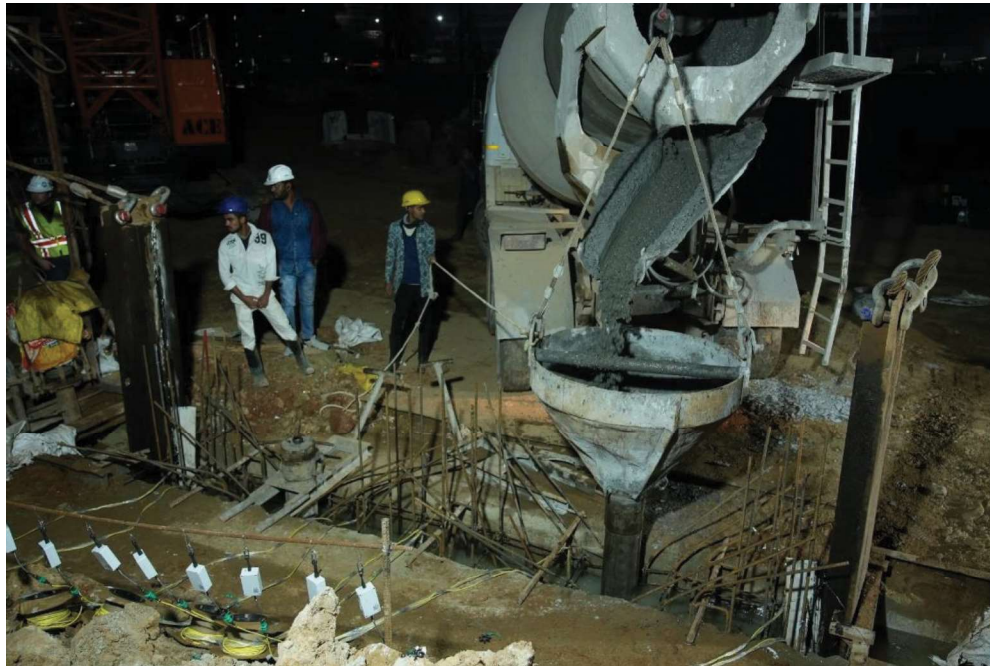
Fig.6 Concreting using Tremie method

Concreting (M30 Grade) commenced after the thermal wires were connected to the TAG and TAP-EDGE data loggers and cloud configuration to access real-time data was complete. Wires 1,7, 8, 9 & 10 were placed on the Soil Face (FF - outside excavation). Wires 2, 3, 4, 5 & 6 were placed on the Excavation Face (NF - inside excavation). Wires 1 & 2 and 6 & 7 are wires on corners. The concreting was performed using the tremie method at 2 different locations within the cross-section of the panel as shown in Fig 5 and Fig 6.

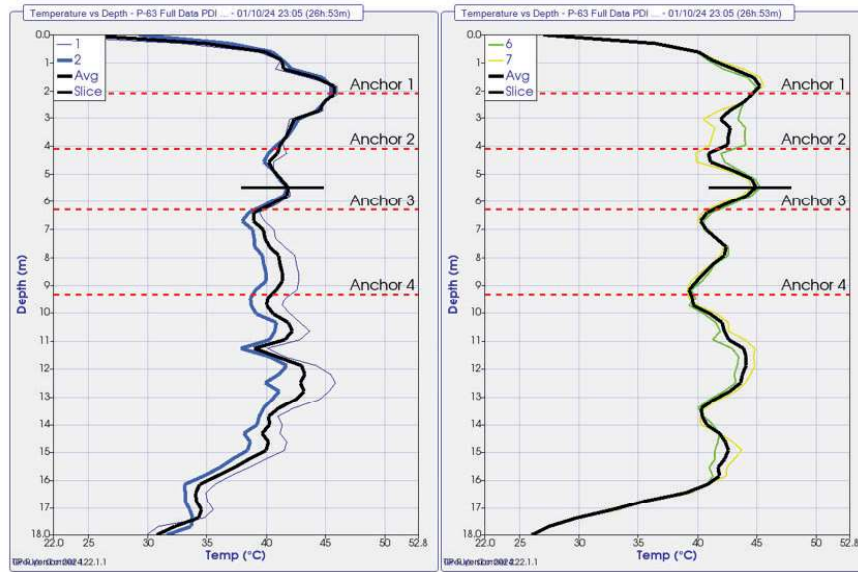
Fig 8. Left corners wires 1 & 2 & Right corner wires 6 & 7 (Left to Right)

Left corner wires 1 and 2 indicated minor inclusion at 11 m and reduction in concrete volume from 15 to 18 m. Right corner wires 6 and 7 indicate reduction in concrete volume from 16 to 18 m (Fig 8). Soil temperature at the base is expected to be 24 degrees Celsius in Bangalore where peak here is only 25 degrees C. Cage alignment on wire 1-2 side is less centered than 6-7 side. Anchor access duct signatures can be seen on wires embedded on the face of D-Wall as presented in Fig 9.

- There are observed reductions in temperature indicative of a soft bottom from 15 to 18 m, particularly in wires 6 & 7 (Right corner of the D-wall).
- Corner wires 1 and 2 (on the left) indicate minor inclusion at 11m whereas the same is not evident in other thermal wires.

- On the left corner with wires 1 and 2, the cage alignment appears slightly shifted. The maximum temperature variation between these wires is 5 degrees, indicating a minor inconsistency.

- Hence, the Integrity of the Panel-63 Diaphragm wall appears to be satisfactory. However, the minor anomalies can be sorted when the adjacent panels and secondary panels are constructed.

- It is further recommended to verify the geometry of the adjacent D-wall panel to acquire more information on panel-63.
