Remote SQUID Testing at Frankfort Road over Raccoon Creek – ECMS 101165

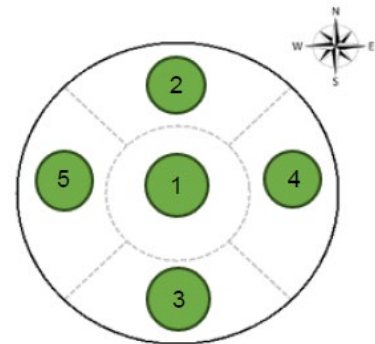
Figure 1. SQUID bottom Testing Locations

SQUID tests were conducted at 5 locations around the base of each shaft (**Figure 1**). A Shaft Quantitative Inspection Device (SQUID) (**Picture 1**) utilizes three penetrometers and three displacement plates to measure force and displacement of debris at the bottom of a drilled excavation, quantitatively assessing the base cleanliness (**Figure 2**). The SQUID is deployed using the drill rig's Kelly bar.

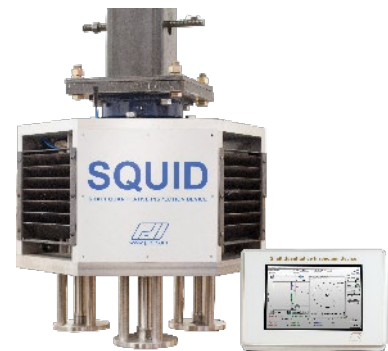
Picture 1. SQUID Device

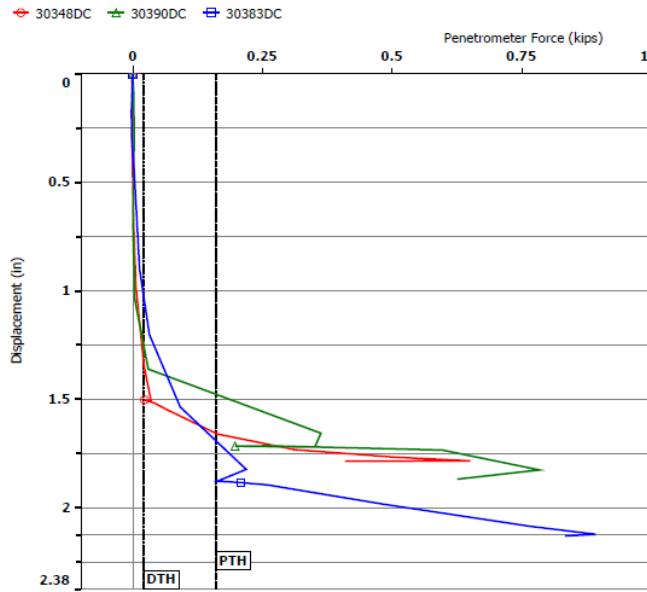
Figure 2. Force vs Displacement Results from SQUID (from the 3 penetrometers)

Flat Tip penetrometers	30348DC	30390DC	30383DC
Disp. at 0.160 kips (in)	1.66	1.48	1.69
Disp. at 0.020 kips (in)	1.31	1.24	1.01
Debris thickness (in)	0.34	0.24	0.68

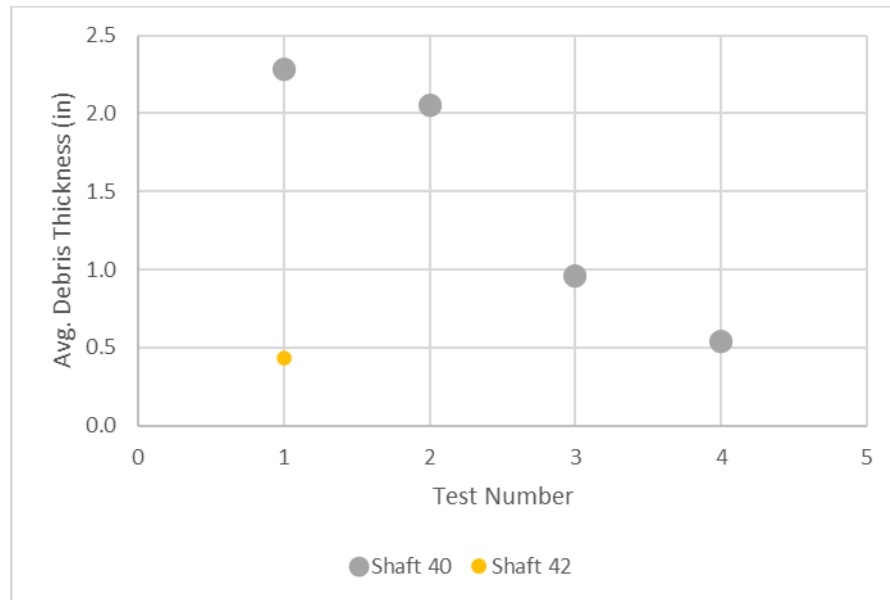
Figure 4. Test number and Debris Thickness for shafts 40 & 42

SQUID tests indicated sediment/debris thickness above specification for several shafts during the initial testing. Cleanout methods were repeated and optimized over the project lifespan to yield acceptable debris thicknesses for all shafts (**Figure 3**). Specifications for debris thickness prior to concrete placement were eventually met for all 43 shafts. During the initial testing, some shafts required up to 4 tests before the cleanliness requirements were met, while most tests indicated acceptable results on the first test after optimizing cleanout methods based on earlier test results. **Figure 4** represents the test number vs. the average debris thickness for an early-stage test (shaft 40) and an optimized single test (shaft 42). All SQUID tests were completed in less than 15 minutes, with most tests completed in under 10 minutes, which helped with the field operations' pace. Additional savings in testing costs and project time reductions were enhanced with GRL's Remote Testing Services.
