1100 Broadway Avenue in Oakland

Case Pacific Company in California contacted GRL Engineers to help collect high-strain dynamic measurements on two Cast-In-Drilled-Hole piles. The project in Oakland at 1100 Broadway Avenue, was initiated to update an abandoned foundation. The unknown limitations of the foundation brought the need to perform a high-strain dynamic test. GRL conducted this test, along with APPLE drop-weight testing, <u>CAPWAP® analysis</u>, and soil/pile set-up characterization.

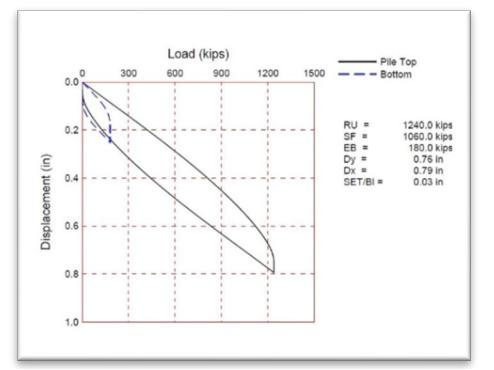
Figure 1: APPLE load test displacement vs load results

The transferred energy to the gage location, below pile top, ranged from 52 to 58 kip-ft for the impacts that were analyzed with CAPWAP. The maximum CAPWAP-computed compressive stress value was 4.2 ksi. Maximum computed tension stress levels were at or less than 0.9 ksi (fig. 2). The PDA measurements showed no clear indication of pile damage in the force and velocity records. The activated capacities calculated by CAPWAP analysis for the two test piles, were 1240 and 1760 kips, respectively. Additional pile resistance may have been activated with a larger energy applied to the piles.
