Empirical Assessment of Base Material for a Drilled Pipe Pile

Project Description

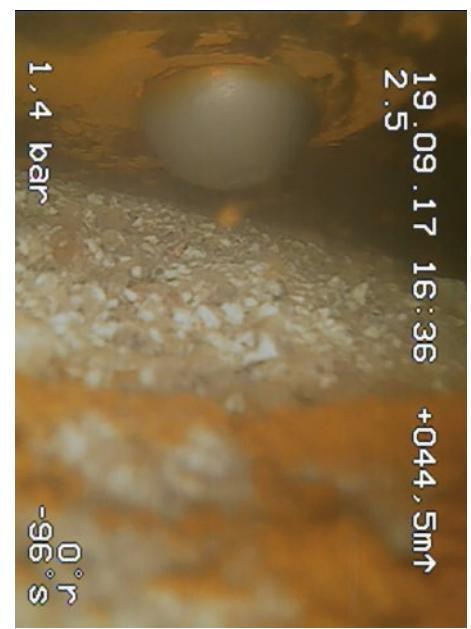
View of gap between button-bit at bottom of the pipe pile and top of rock layer

The foundation system for the project was designed for end-bearing resistance only, where all of the nominal loads were supported by the base material blow the foundations. The following criterion were followed to determine the final base elevation: (1) minimum drilling advance rate of 40 min/m (12.2 min/ft) corresponding to a limit base resistance of approximately 150 MPa (22 ksi) and (2) visual inspection using a down-hole camera to ensure contact between the rock layer and the base of the foundation element. Once the elevation was defined using the drilling rate data, the base of the drilled pile was cleaned using an airlift system, and then a down-hole camera was lowered to inspect the bottom of the pipe to ensure full contact with the rock layer.

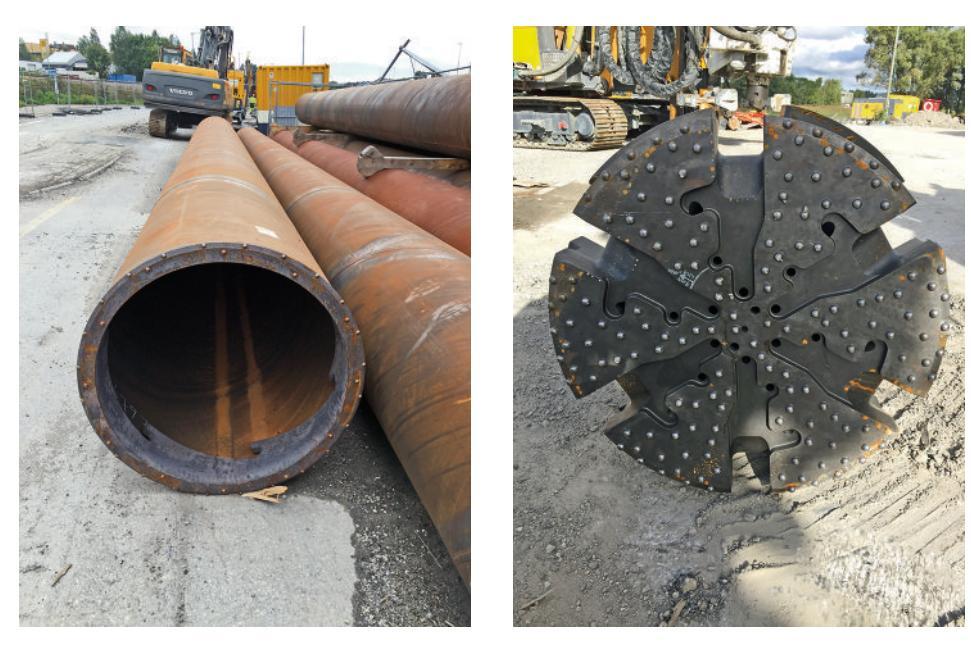
(L) Button driving ring at tip of pipe pile and (R) bottom of a DTH to fit inside pipe pile

The project is related to the foundation system of a vehicular bridge crossing the Seutelva River, located in Fredrikstad, Norway. According to the project information, the proposed bridge will be supported by 25 ea, 1,016 mm (40 in) diameter open-ended pipe piles advanced to the competent rock layer. Each bridge bent consists of five open-ended pipe piles, which will be filled with concrete after reaching the final base elevation. These piles were installed using a DTH hammer system, which uses the rotary-percussion drilling method with a button bit with its outer diameter being the same as the inner diameter of the pipe pile. The

drilling process is completed by using a first pile section with the button driving ring and a button-bit hammer fitted through the pile using a drill string.

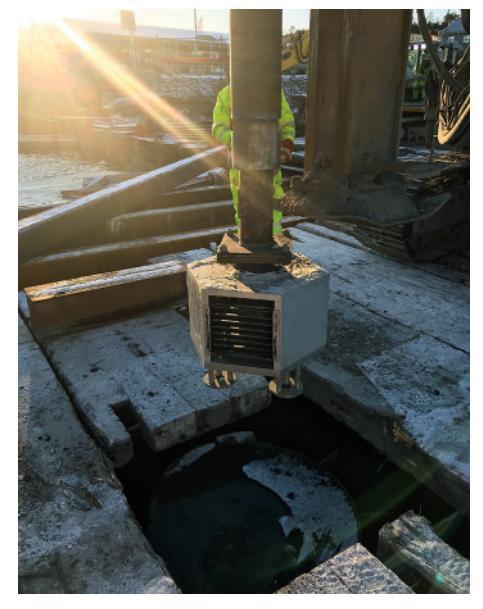
Attachment of the device to the end of a drill string

The device was attached to the drill string using an American Petroleum Institute (API) adapter located between the swivel plate and the drill string and was then lowered into the drill pipe to initiate test runs at the base of the foundation. Once the device contacts the base material, an axial force is applied using the crowd (downward thrust) from the drill rig. The resistance to penetration is measured by the penetrometers, while the displacements are measured by the retractable plates.

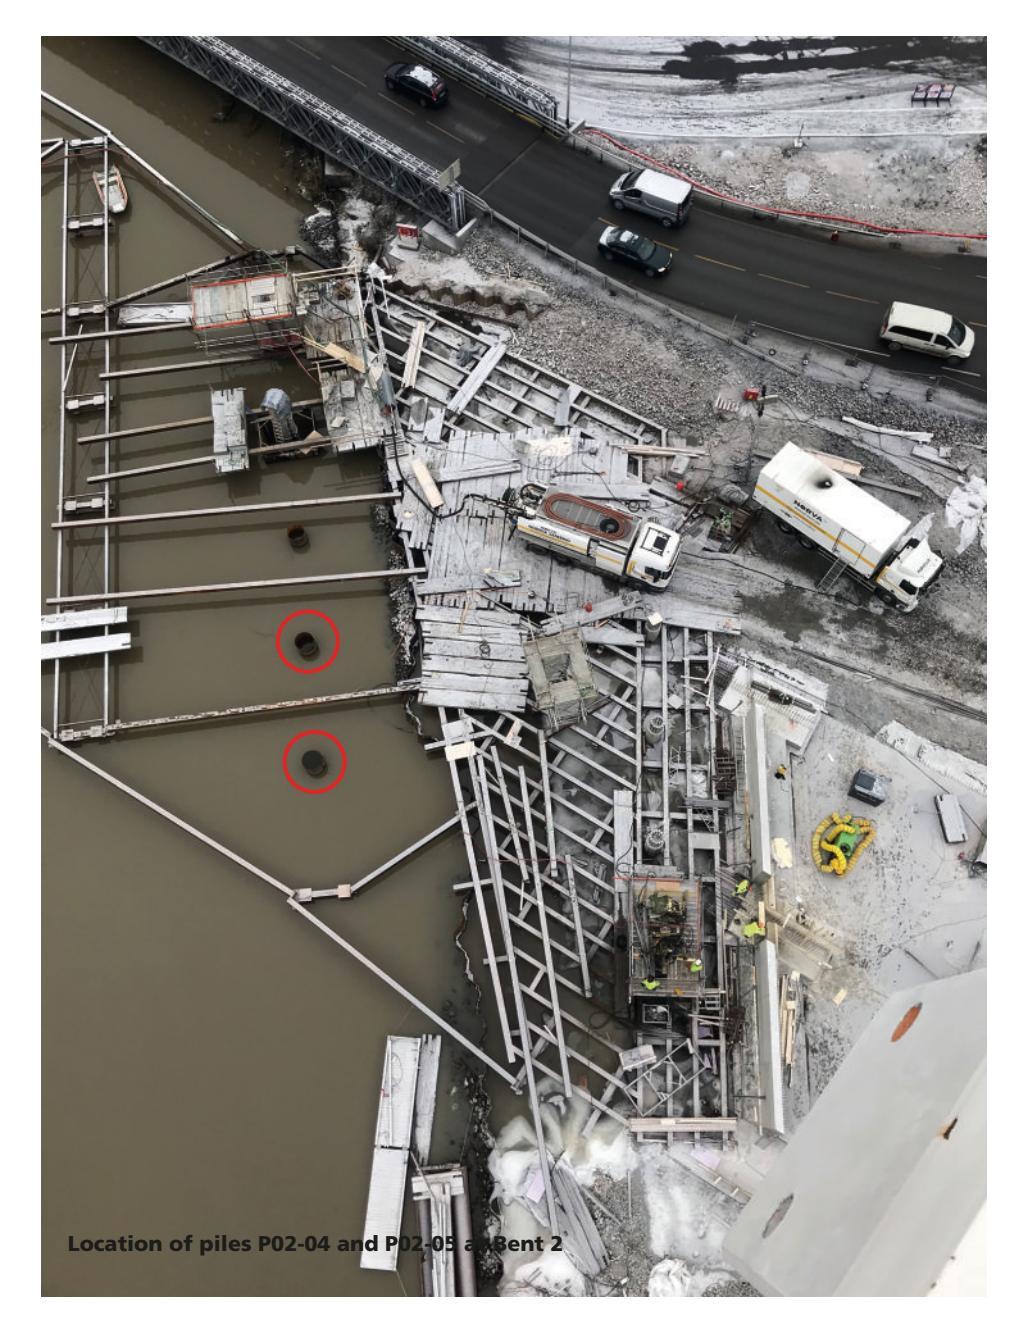
A total of 10 runs were performed at the base of the pile P02-04 to obtain the data to determine the force-displacement relationship. Each of the applied forces was then divided by the cross-sectional area of the penetrometer to obtain the applied stresses. Stress-displacements plots for pile P02-04 were plotted individually to visualize the force-displacement behavior and to evaluate the criterion established for the material at the base of the foundation. The results obtained for pile P02-04 indicated that each of the three penetrometers follow a similar trend. However, the nonuniform (i.e., not overlapping) plots behavior indicated that the base of the foundation was not completely flat. Furthermore, according to the plotted results, the average stress and displacement for the material at the base of the foundation were determined to be 35 MPa (5.1 ksi) and 7 mm (0.28 in), respectively. These values were within the established resistance and displacement thresholds for the competent material at the base of the foundation.

It is important to note that FD1 plot slightly exceeds the displacement threshold limit of 8 mm (0.32 in) with a stress value of about 24 MPa (3.5 ksi) and a maximum stress of 34 MPa (5 ksi). However, the other two plots (FD2 and FD3) are within the established threshold values. Another important observation is

the similarity in the shape of the relationships from the start of the test up to approximately 10 MPa (1.45 ksi) where a steady increasing slope is observed. Beyond this point, the relationships transition to a more constant and gentler slope with increasing stress, which may indicate an abrupt change in material property possibly indicating going from softer rock to more competent rock. However, a visual inspection using a downhole camera, as discussed above, did not reveal softer material accumulated near the base of the foundation. Therefore, the existence of a softer rock versus a more competent rock is more likely to be the case at this location.

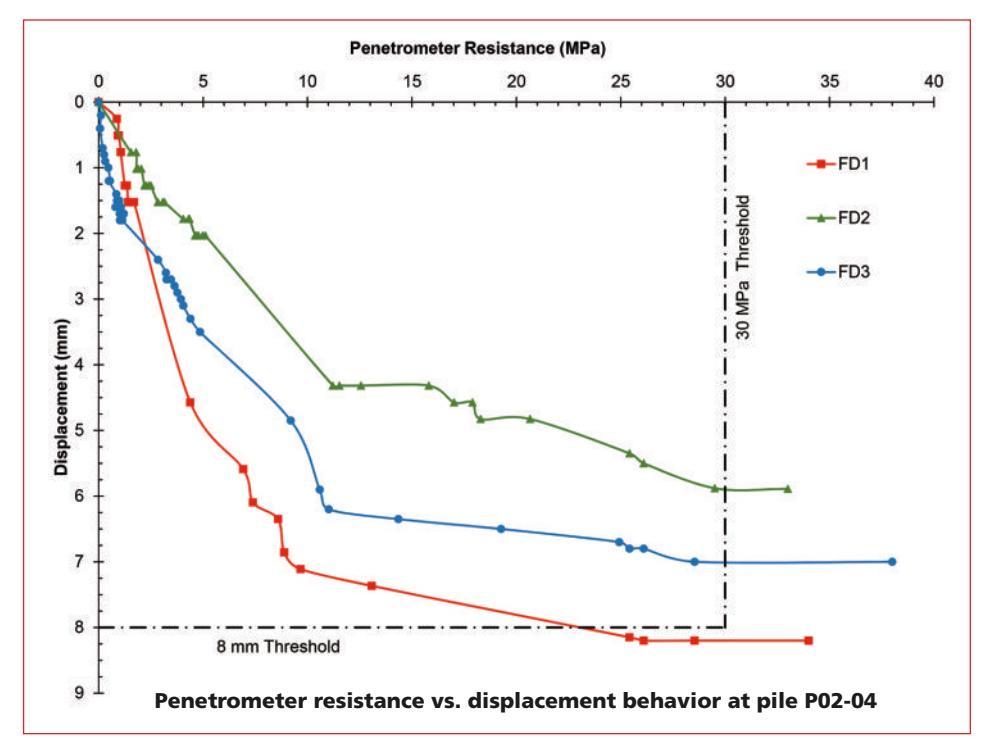
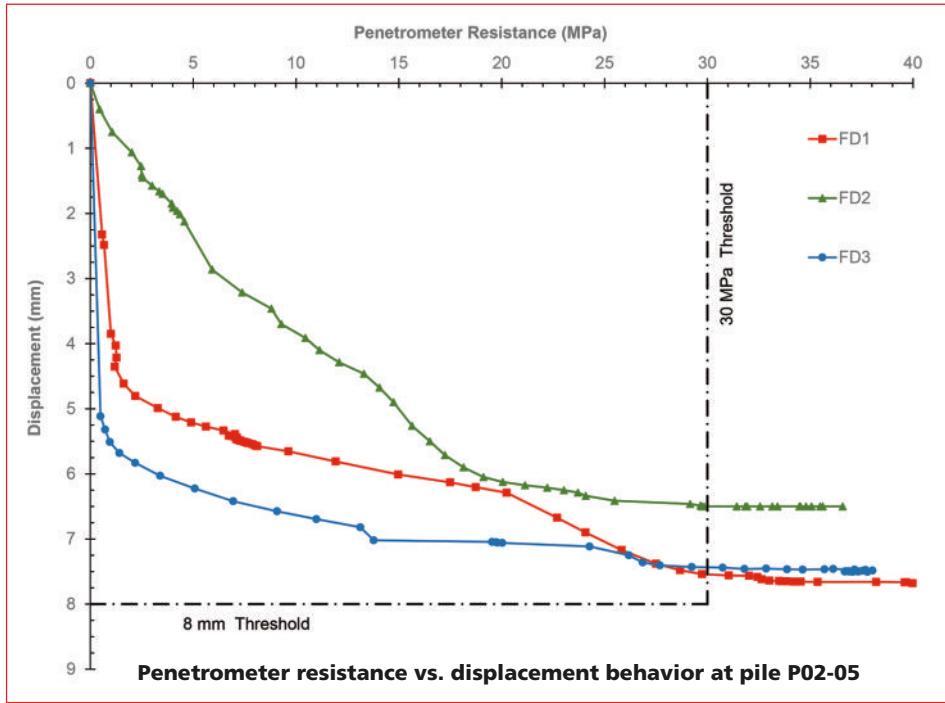
Similar to those performed at pile P02-04, a total of 13 runs were performed at the base of pile P02-05 to obtain the data to determine the force-displacement relationships. The graphs of the stressdisplacement relationships were analyzed to evaluate the behavior of the material encountered at the base of the foundation. The results indicated that each of the three penetrometers follow a similar trend, especially toward the end of the test. Similar to the tests at pile P02-04, a nonuniform material at the base of the foundation was detected, which was evident from the plots as the individual graphs were not overlapping. Considering the maximum stress measured by each

penetrometer and the corresponding displacements, the average stress and displacement for the material encountered at the base of the foundation were determined to be about 38 MPa (5.5 ksi) and 7.2 mm (0.28 in), respectively.

It is important to note that trend of FD2 is different compared to FD1 and FD3. The relationship for FD2 indicates a linear behavior with a constant slope up to a stress value of approximately 20 MPa (2.9 ksi) when the abrupt change of slope occurs. From this point forward, the relationship flattens to an almost zero slope with increasing stress along with a very small change in displacement. The relationships for FD1 and FD3, on the other hand, follow a similar shape to each other and can be divided into three segments: (1) a steep slope from a stress of 0 to about 1.7 MPa (0.25 ksi), then (2) a small slope between 1.7 MPa (0.25 ksi), and 29 MPa (4.2 ksi), and then (3) a near zero slope after 29 MPa (4.2 ksi). The first portion of these plots could correspond to a very soft material accumulated at the base of the foundation,

which is then followed by a material with higher strength (e.g., weak or weathered rock). The third segment is where the abrupt change occurs similar to FD2 and the graphical relationship (similar to pile P02-04) indicates the existence of competent material or rock that satisfies the established criteria.
