Newsletter No. 42

September 2002

### Crosshole Sonic Logging

by Scott Webster, GRL Engineers, Inc.

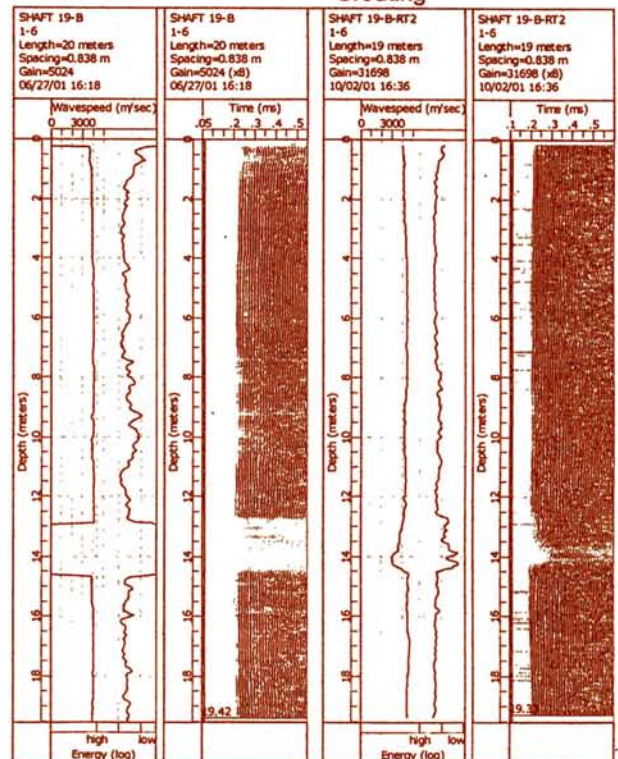
Generally, GRL's experience suggests that the percentage of defective shafts on a given project is relatively small. However, on a recent project three of the fifty shafts tested were found to have defects. The original testing program consisted of testing only four out of fifty shafts. The left CHA record shown here, for tube pair 1-6

of one of these four shafts, clearly suggested a problem. After the CSL testing revealed this defect, the shaft was cored, confirming segregated concrete, i.e. mostly gravel, at the depth indicated. Post grouting of the zone of bad concrete was then performed and CSL testing was repeated. The right half of the figure shows a CSL record taken after the remedial grouting, and confirming that the grouting substantially improved the concrete quality in the affected zone.

Original CHA Record

CHA Record after Post Grouting

After CSL revealed this production shaft with segregated concrete in the shaft middle (14 m depth), it was decided that all shafts should be CSL tested. Two more defective shafts were found, this time with a problem "soft toe". These shafts were core drilled to confirm the CSL results and were repaired by post grouting. Again, CSL tests performed after remedial grouting confirmed adequately repaired shafts.
